## OBSERVATIONS ON THE FAILURE MECHANISMS OF MASONRY STRUCTURES CAUSED BY THE KAHRAMANMARAS EARTHQUAKE ON FEBRUARY 6, 2023

**Abstract.** In this study, the failure modes of masonry structures after the earthquake occurred in Kahramanmaraş on February 6, 2023 were investigated by fieldwork. In this study, information was given about the building stock in the Turkey and the Middle East countries, and a literature including studies examining the general failure modes in masonry structures was presented. After presenting the ground acceleration data and earthquake parameters measured during the earthquake, damage distributions in historical masonry structures and masonry structures used as residences were examined. Failures were examined as out-of-plane, in-plane, and corner damages. In the examinations, it has been determined that the failure mechanisms are triggered by unqualified wall-slab and wall-floor connections, insufficient axial load and material-strength, poor workmanship and lack of engineering service. In addition, how an earthquake resistant masonry structure could be build also discussed.

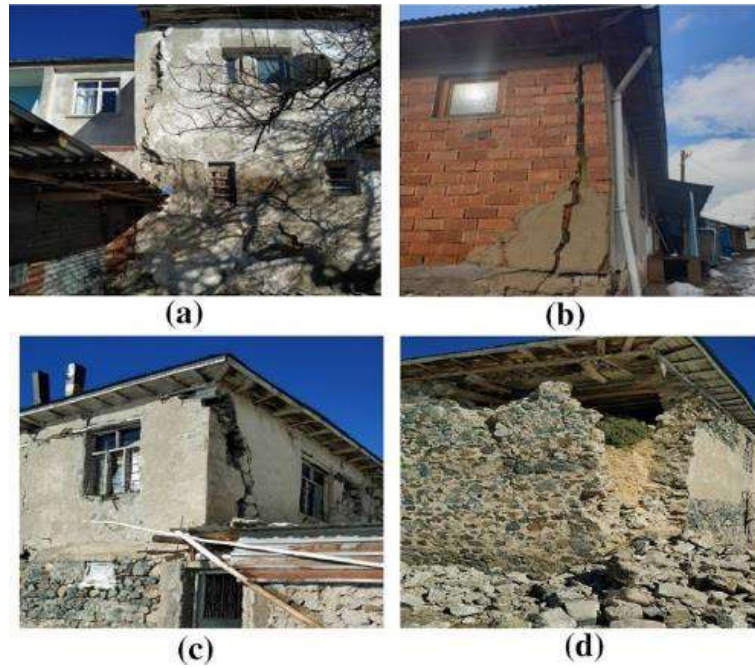
**Figure 2.** Corner failure mechanisms in masonry structures in the town of Sivrice [6]

Photographs of a study carried out after the Sivrice (Elazig) earthquake on February 9, 2007 are shown in Figure 2. As can be easily seen from the photographs, corner failure mechanisms are present in the masonry structures in the region.

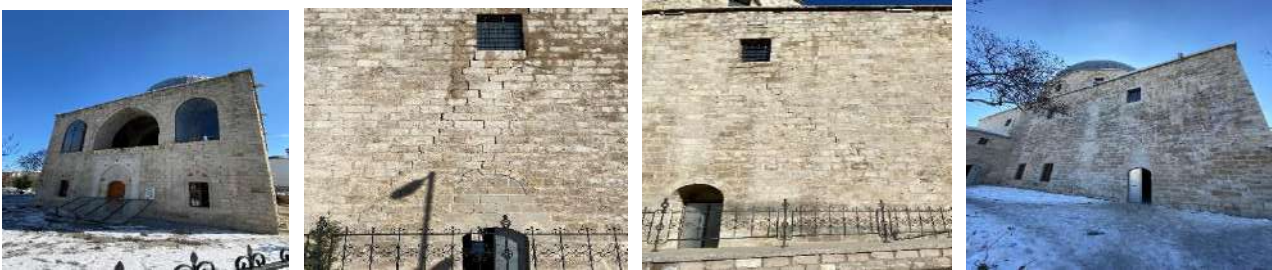
**Figure 9.** Damage distribution of Taşhoran Culture and Art Center [10]

Tashhoran Culture and Art Center. Damages in this structure are shown in Figure 9. A rather large arch-shaped frontal window on the entrance door has fallen to the ground. Although this is not the damage to the carrier system, considering the weight of the glass and the floor it falls on, it is seen that the connection quality of such elements is very important. In addition to this, some diagonal shear damages occurred, the largest of which was at the junction of the stone blocks forming the wall on the right front. These shear damages occurred at the mortar interface. There was no crushing or out-of-use in the carrier units.

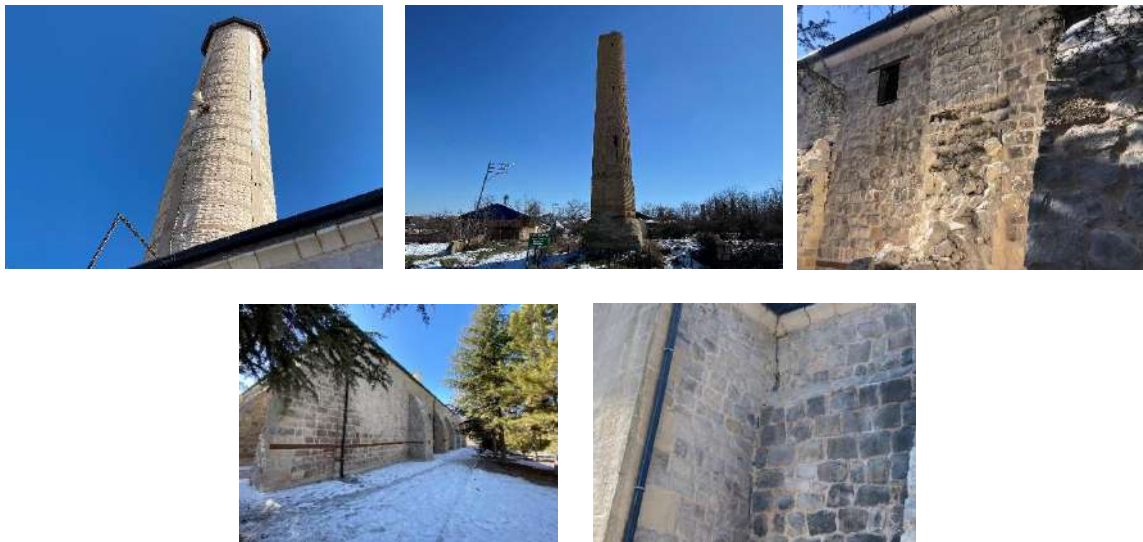
**Figure 10.** Damage distribution of Ulu Cami [10]

**Ulu Cami.** Damages detected in the historical Ulu Mosque are shown in Figure 10. No damage that could cause collapse has been detected in the minaret, which was previously reinforced with carbon fiber textile. Local capillary mortar cracks were observed in some areas. A nearby historical minaret, which was built at the same time, was heavily damaged because no reinforcement was applied. Deep vertical cracks formed in the middle part of the minaret were detected. At the ends of these deep cracks, failure of the joint mortars due to rotation and peeling of the bricks were observed.

In addition to these, collapses occurred in the regular masonry system buttresses, which were built in order to prevent possible out-of-plane collapses on the walls. There was no serious damage to all buttresses. However, while some of them had adherence losses at the junction with the main wall and local failures in the masonry overflows (left), some of them were completely destroyed. The absence of any curvature in the plane of the anchor rods driven into the main wall indicates that these rods did not hold the buttress wall sufficiently during the earthquake.

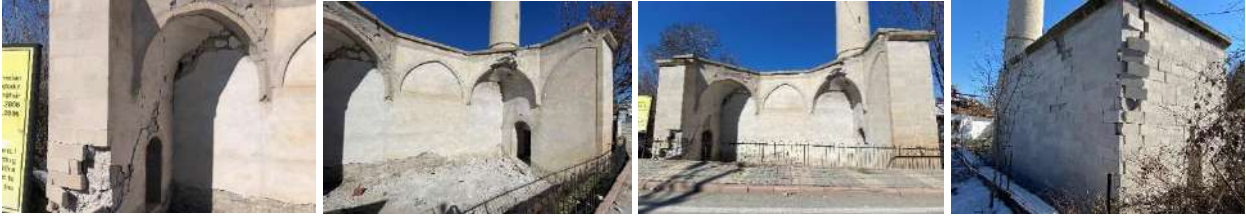
**Figure 11.** Damage distribution of Sütlu Minare Cami [10]

**Sutlu Minare Cami.** In the structure shown in Figure 11, the shear cracks starting from the minaret floor on the left progressed diagonally, causing deterioration in the wall of the arch in the middle. In addition, as examples of vertical and horizontal discontinuities, it has been severely damaged due to the irregularity of the blocks in the building and the position of the arch in the middle. In addition, the corner failure mechanism, which occurs as a result of out-of-plane behaviors, was observed.

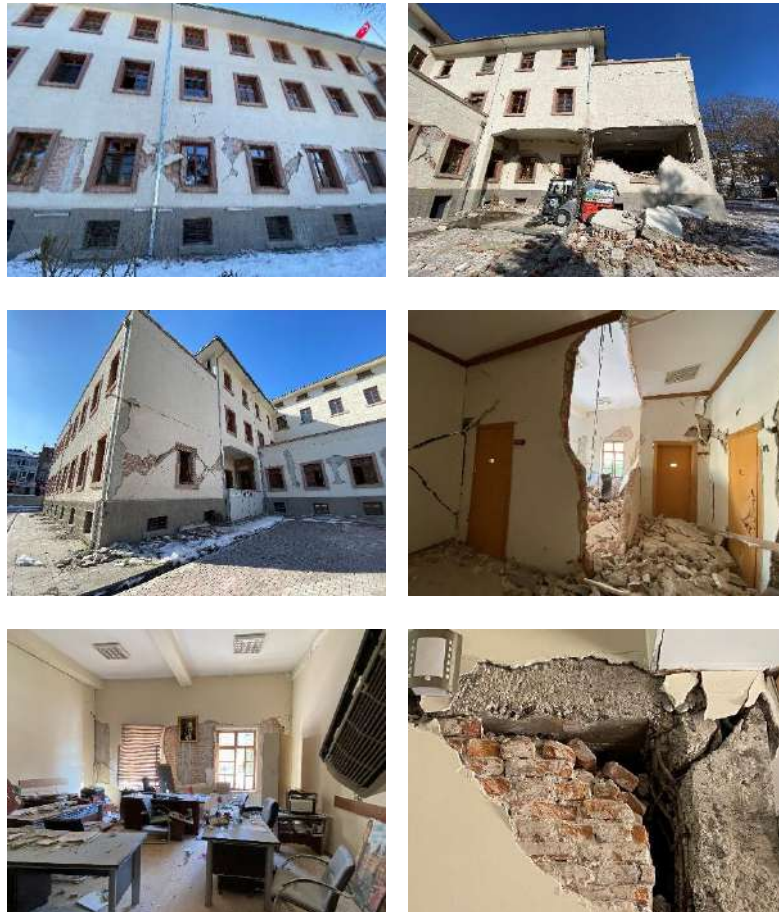
**Figure 12.** Damage distribution of Malatya Governor's Office [10]

**Malatya Governor's Office.** In Figure 12, the damage distribution of Malatya Governorship Building after the earthquake is given. The first image shows the typical shear damage of masonry structures, especially on the ground floors. In the wall spaces between the windows, X-shaped diagonal shear cracks formed as a result of the impulse-tensile effect. Thanks to the vertical and horizontal alignment of the gaps on the frontal and the siege beams, the cracks formed here proceeded in a controlled manner and did not result in any collapse on this frontal.

As can be seen from the second image in Figure 12, diagonal shear cracks were formed in the wall part between the windows on the left and middle part of the building. In addition, linear connection cracks have formed between the masonry wall and the vertical and horizontal beams. On the right side of the building, the

horizontal bending effect disrupted the vertical stability of the wall, while the vertical bending effect caused out-of-plane rotation damage in the middle part of the wall. The cracks produced by this rotational damage were combined along the wall cross-section with X-shaped diagonal shear cracks formed as a result of in-plane behavior. As a result, collapse occurred as a result of the articulation in the middle region of the wall.

From the third image in Figure 12, it was determined that typical shear cracks were formed in the wall part between the windows on the left and right of the building. The horizontal and vertical distribution of the windows and the presence of horizontal and vertical beams prevented the progression of these cracks throughout the building.

As shown in the fourth image in Figure 12, it has been determined that there are serious cracks and failures on the walls in the interior of the building. First of all, serious cracks were seen extending from the door openings to the upper floor. Quite wide and deep shear cracks developed on the left. Corner failure mechanism of the two walls and out-of-plane collapse of the right wall drew attention in the middle region. The main reason for these collapses can be i) the lack of horizontal beam application despite the rather large wall height, ii) the irregularity of the partitions such as rooms, corridors or doorways in the plan, iii) the discontinuity of the masonry walls in the interior of the building.

In the fifth image, plaster cracks, which can be considered as slightly damaged, are shown. Very thin capillary, non-progressed cracks were observed in the masonry wall opposite. In the last image, the heavy shear damage at the junction of the vertical and horizontal beams is shown. Stirrups were opened, longitudinal reinforcements yielded.

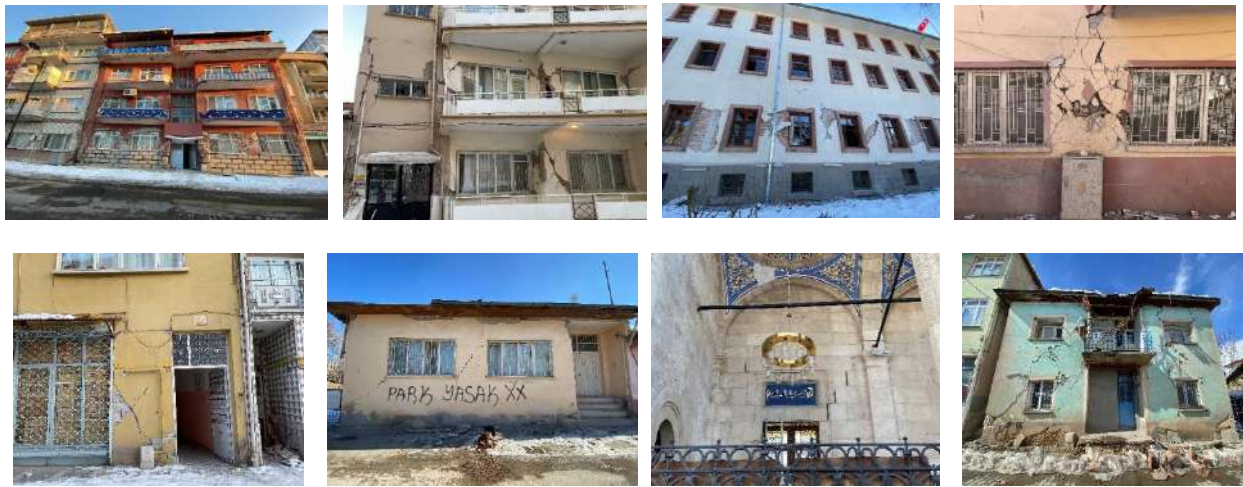
**Figure 13.** In-plane damages in masonry structures in Malatya [10]

*Damage distribution of masonry structures.* In this section, firstly, images related to in-plane, out-of-plane and corner failure were shared. While the in-plane damage distributions are shown in Figure 13, the images related to the out-of-plane and corner mechanisms are shown in Fig.14. In addition, examples of tie beam application preventing the failure of the entire building are shown in Fig. 15.
