SEISMOLOGICAL, GEOTECHNICAL AND STRUCTURAL ASPECTS OF THE 2023 KAHRAMANMARASH, TURKEY EARTHQUAKE SEQUENCE

Erberik Murat- prof., Department of Civil Engineering, Middle East Technical University, Turkey

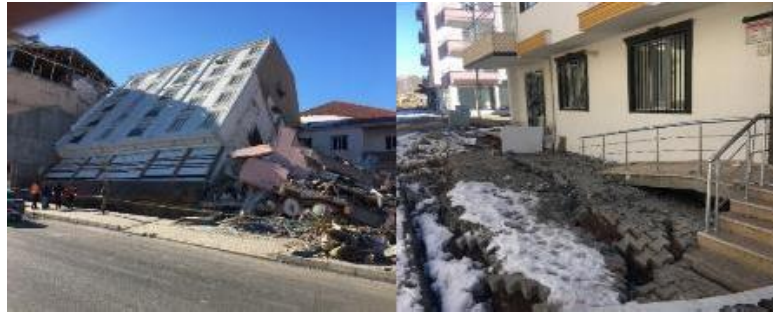
Ground damages and geotechnical findings. Adiyaman City0 in the Golbasi district of Adiyaman province, the presence of groundwater levels near the surface and alluvial soils has led to remarkably high damage, particularly due to liquefaction-induced phenomena. In the flat areas of the city center, nearly all structures, although not exhibiting structural damage, have experienced substantial settlements. Structures built under similar conditions but extending towards the highland topography, however, have not encountered settlement or other types of damage.

Figure 6 displays a building that has entirely tilted backward on its foundation without any deformation in its structural elements. The other photographs illustrate the soils have liquefied, leading to the settlement of the building foundations and bulging of the soils surrounding the foundations.

Figure 6. Tilting of buildings and heaving of soils around foundations due to liq-uefaction (Adiyaman- Golbasi) [19]

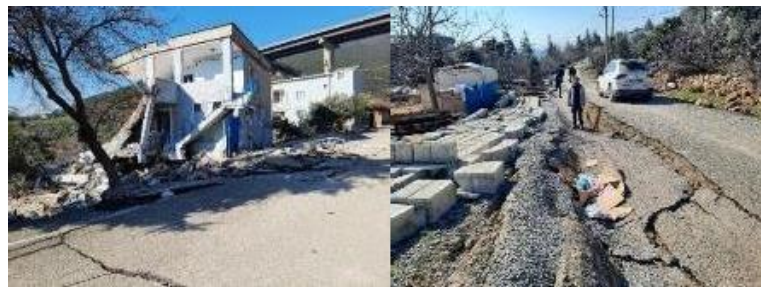
Nurdagi is one of the districts in Gaziantep that was directly affected by surface fault rupture. Due to surface faulting, large damages occurred in houses (Fig.7.a) and large deformations and settlements occurred on road routes (Fig.7.b).

Figure 7. a) Major damage to houses due to surface faulting (left), b) deformations and settlements due to surface faulting on the road in Nurdagi (right) [19]

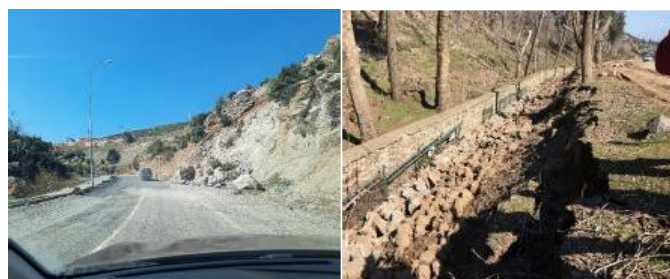
Large mass failures due to rockfalls were encountered on the slopes along the Gaziantep Osmaniye road east of Nurdagi (Fig.8.a). The retaining structure along the water canal on the railway route in the Fevzipasa neighborhood of Islahiye (Gaziantep province) collapsed towards the canal due to lateral spreading (Fig.8.b).

Figure 8. a) Rockfall on the road route around Nurdagi, b) damages due to lateral spreading along the stream channel in the Fevzipasa neighborhood of Islahiye [19]

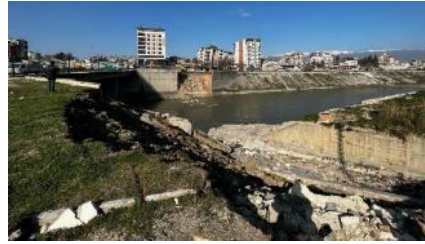
Asi River. Especially in the center and districts of Antakya along the Asi River, settlements and lateral spreading due to alluvial soils increased the structural damage (Fig.9).

Figure 9. Settlements in alluvial soils along the Asi River in Hatay and damage to retaining walls due to lateral spreading [19]

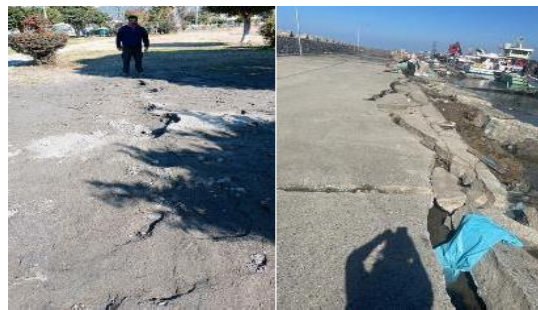
In the Cay neighborhood located within the borders of the Iskenderun district of Hatay province, sand boils due to seismic liquefaction was observed intensively. The seaside fishing harbor in Iskenderun was heavily damaged in the earthquake, and differential settlements were observed in the region (Fig.10).

Figure 10. Surface manifestations of the sand boil as seismic liquefaction in Iskenderun Hatay (left), lateral spread due to liquefaction in the fishing harbor area in Iskenderun, Hatay (right) [19]

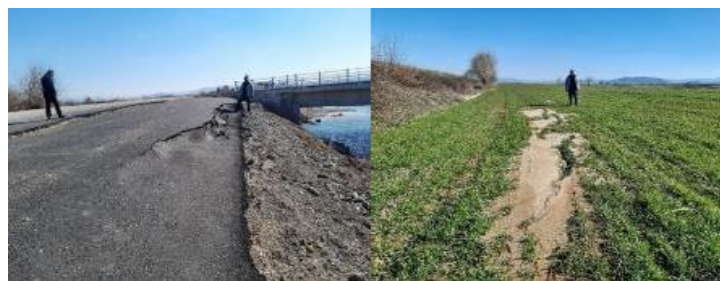
Traces of surface faulting along the EAFZ in the Turkoglu district are observed at the east of the district. Since a significant part of the district is located on alluvial deposits, these soils were especially effective in increasing the damage in the area. Lateral spreading and sand boil due to soil liquefaction were observed in the region (Fig.11.a and 11.b).

Figure 11. a) Lateral spreading (left), b) sand boiling due to soil liquefaction (right) [19]

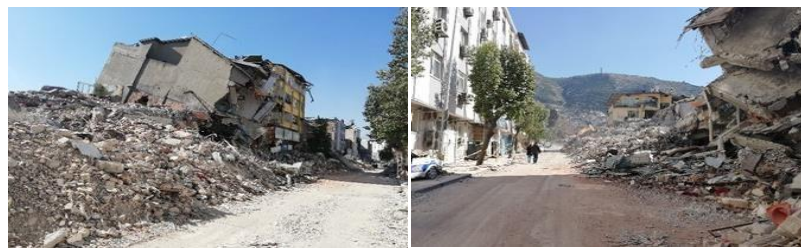
Antakya, Hatay is the most adversely affected city from this earthquake sequence. This is due to the fact that the ground motion intensities had been drastically amplified due to soft site conditions and the directivity effect of the ruptured fault in the first earthquake. In addition, a large aftershock with $M_w=6.4$ took place in the vicinity of the affected region and caused further destruction among the damaged structures. At the center of the city near the Asi River, there is total destruction as seen in Fig.12.

Figure 12. The photos of total destruction in Antakya, Hatay (courtesy of the EEAT) Antakya city was recognized for its cultural diversity and richness and it resided many historical structures, including invaluable heritage belonging to different religions. Unfortunately, most of these structures were either severely damaged or collapsed during the sequential earthquakes of February 2023 in Turkiye (Fig.13) [19]

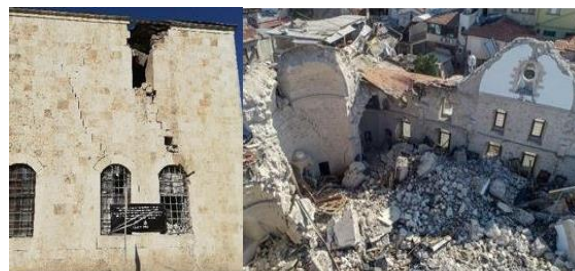
Figure 13. Damaged historical structures in Antakya after earthquake sequence; a) Habib-i Neccar Mosque (courtesy of the EEAT), b) Rum Orthodox Church [19]

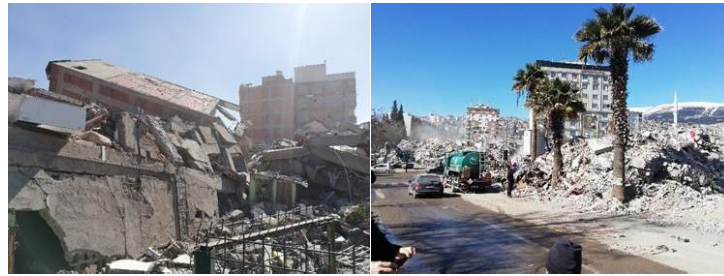
Another highly affected city center, which is close to the epicenters of both Mw7+ earthquakes is Kahramanmaras. Especially the mid-rise reinforced concrete (RC) buildings in the old city center that resides on soft soil deposits were razed down under strong shaking (Fig.14).

Figure 14. Complete destruction in Kahramanmaras city center (courtesy of the EEAT) [19]

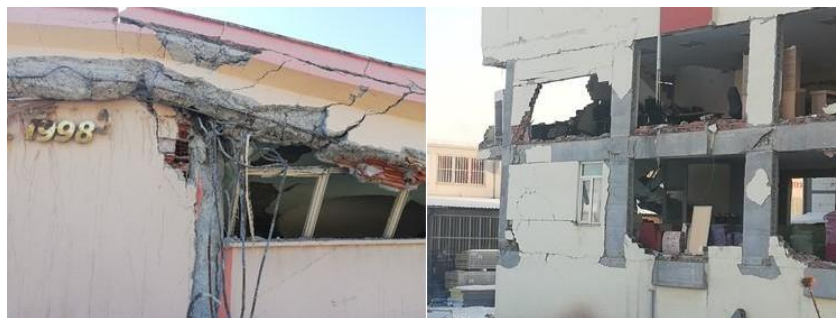
Similar views of damaged buildings exist in the city centers of Adiyaman and Malatya. This high percentage of building damage seems to depend on many factors from the design stage to the construction stage of these buildings. The adversely affected buildings with ordinary beam-column framing systems have been observed to be very flexible. This dynamic nature seems to have caused extensive drifts during strong shaking beyond the deformation capacity of columns. In addition, the ground story with commercial use worked as a soft-story mechanism in most of these buildings leaving no chance of survival for the occupants. Poor concrete strength, insufficient detailing, and improper supervision during the construction stages of these buildings are among the major issues that caused the high seismic vulnerability of these buildings (Fig.15).

Figure 15. Structural deficiencies observed in damaged buildings (courtesy of the EEAT) [19]

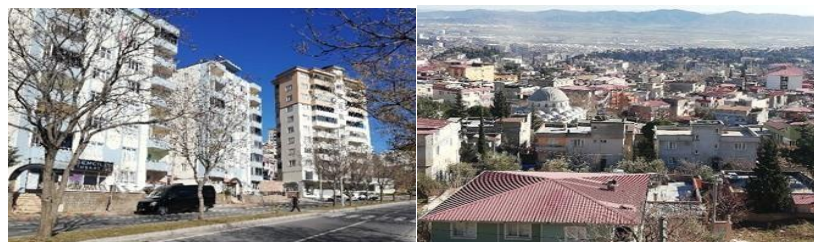
It was also observed that the buildings on the hillsides of the aforementioned city centers with relatively stiff soil conditions performed better during the earthquake with light damage on the non-structural infill walls only (Fig. 16.a). Even old low-rise buildings with poor construction stood still without serious damage (Fig.16.b). This shows the significant variations in seismic demand with changing topographical and soil conditions.

Figure 16. Buildings on the hillside of Kahramanmaras city center; a) (left) new high-rise RC frame buildings with no/slight damage, b) (right) old and low-rise RC and masonry buildings that performed relatively well during the earthquakes (courtesy of the EEAT) [19]

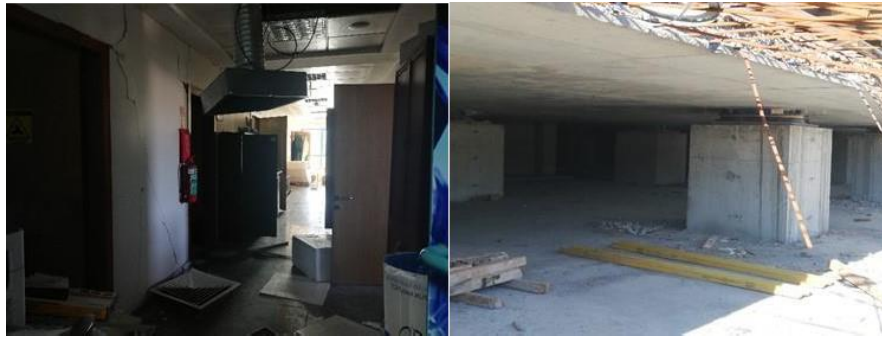
Critical structures like hospitals and school buildings behaved relatively well during the earthquakes. Some hospitals with old and deficient construction collapsed during the earthquake, killing the patients and the medical people inside the buildings. Some others were damaged, especially with extensive non-structural damage, causing the interruption of the medical services during the post-earthquake emergency period (Fig.17.a). Base isolation systems had been used in some newly constructed hospitals and they all showed satisfactory behavior during the strong shaking (Fig.17.b).

Figure 17. a) Existing city hospital in Kahramanmaras with extensive non-structural damage, b) a new hospital construction in Kahramanmaras with base isolation system (the isolators worked and performed well during the earthquake although most of them were not installed yet) (courtesy of the EEAT) [19]

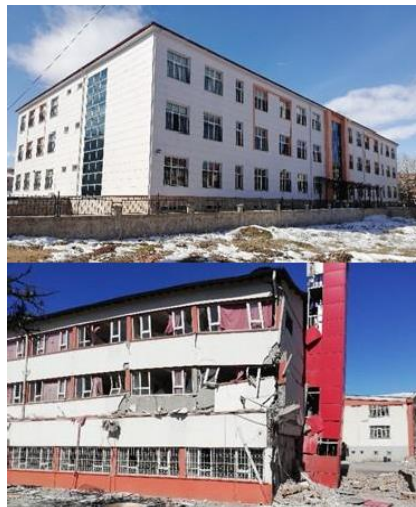
The school buildings also experienced varying levels of structural damage from none to severe damage (Fig.18). It was fortunate that no students were injured during the earthquake sequence since the first main shock happened at 4 a.m. before dawn and none of the schools were open during the second main shock.

Figure 18. a) A school building with no damage in Golbasi (Adiyaman), (top) b) a severely damaged school building in Kahramanmaras city center (bottom) (courtesy of the EEAT) [19]
