INVESTIGATION OF CORNER FAILURE MECHANISMS OF MASONRY STRUCTURES CAUSED BY THE 6 FEBRUARY 2023 KAHRAMANMARAS EARTHQUAKES IN MALATYA

Keywords: masonry structures, corner failure, earthquake, Kahramanmarash earthquake

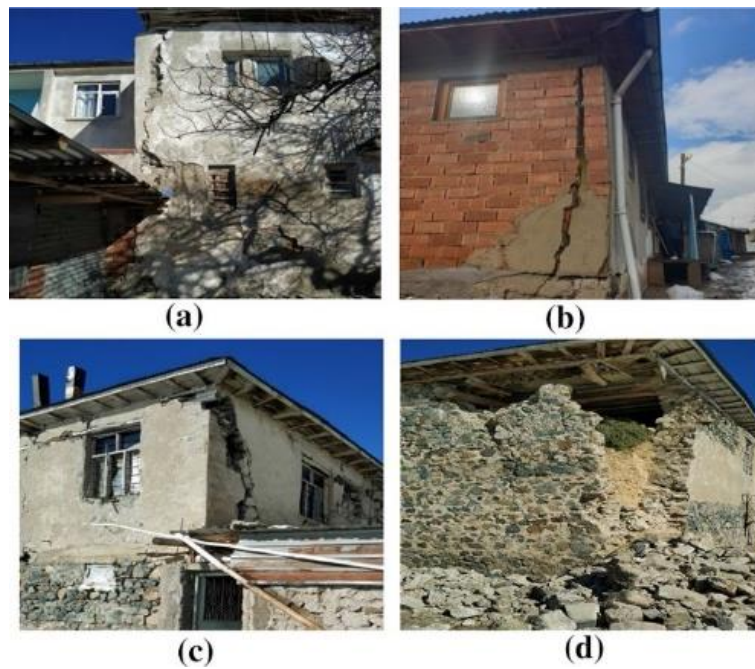
exposed to corner failure mechanisms under the influence of earthquakes. Photographs of a study made after the Sivrice (Elazığ) earthquake on February 9, 2007 are shown in Figure 4. As can be easily seen from the photographs, corner collapse mechanisms are present in the masonry structures in the region.

Figure 4. Corner failure mechanisms in masonry structures in the town of Sivrice [16]

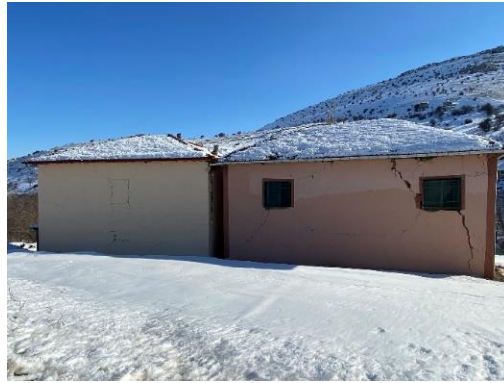
In the field, a 2-storey masonry structure shown in Fig.12 in Akçadağ district met the research team at the coordinates 38,38479 N, 37,95899 E. In-plane shear cracks were seen advancing approximately 45° from the window corners of the building. The horizontal bending crack advancing from the window on the right has progressed to the corner wall-wall junction area since there is no vertical beam. Corner collapse mechanism was triggered as a result of in-plane and out-of-plane damage mechanisms, which occurred as a result of the deterioration of the structural integrity as a result of not making the beam at the roof level and directly supporting the wooden roof to the masonry wall.

Figure 12. A 2-storey masonry building (38,38479 N, 37,95899 E) [17]

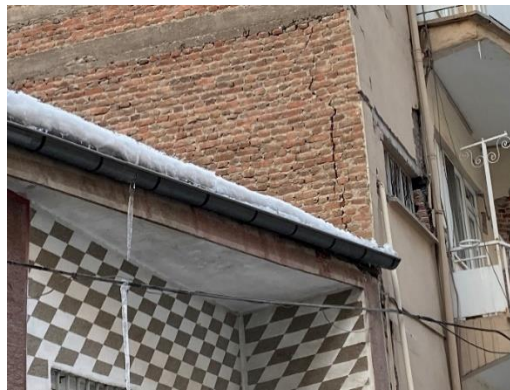
Figure 13 shows the damage in a 4-storey masonry building in the town of Battalgazi at 38.35371 N, 38.32353 E positions. Also, in Figure 13, two masonry structures with adjacent order and not the same number of floors are shown. The corner collapse mechanism was triggered due to the out-of-plane damage on the perpendicular frontal walls of the rear building from the point where the roof level of the front building ends. The architectural irregularities between the buildings and the horizontal and vertical discontinuities of the load-bearing elements trigger out-of-plane collapse and corner failure mechanisms. The horizontal beams applied at the top of the window in the building at the back preserved the structural integrity thanks to the box-type behavior. In addition, by preventing the corner collapse mechanism from advancing along the floor, it prevented the collapse at the frontal junction.

Figure 13. Two masonry buildings with adjacent layout and not the same number of floors (38,35371 N, 38,32353 E) [17]

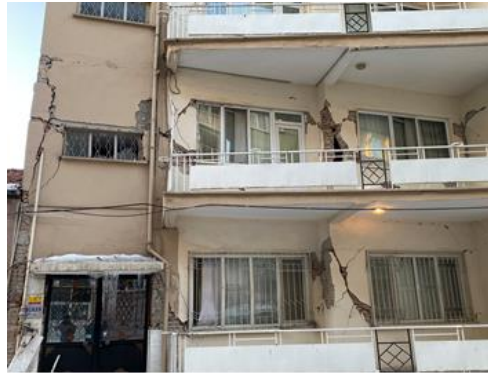
Again, the damage distribution in the masonry structure located at 38.35371 N, 38.32353 E positions in Battalgazi district is shown in Figure 14. Shear cracks were observed in the wall parts between the window openings on the ground and first floors of the four-storey masonry building. Corner failure mechanisms have occurred due to the bossage in these wall parts. In addition, another out-of-plane damage was observed on the left side of the main entrance door at the level of the first-floor of the building.

Figure 14. A masonry structure with a corner failure mechanism and shear cracks (38.35371 N, 38.32353 E) [17]

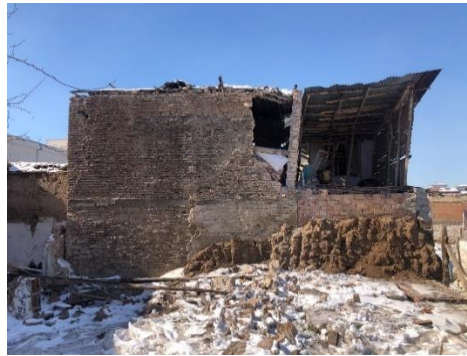
In Figure 15, the damages of a 2-storey masonry structure at 38.35267 N, 38.31155 E positions in Battalgazi district are shown. In the two-storey masonry structure seen, failure mechanism due to lack of roof and diaphragm, collapse of the wall part due to out-of-plane bending mechanism (left), heel bending of the partition wall (middle), wall collapse due to in-plane shear damage (middle)

Figure 15. Damage distribution of a masonry structure (38.35267 N, 38.31155 E) [17]

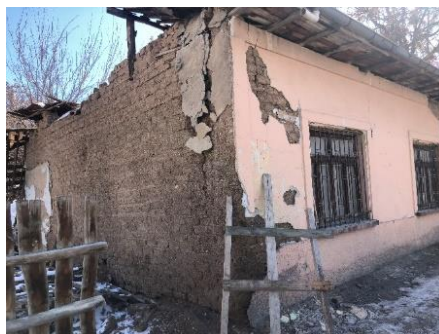
Another masonry structure, which is very close to the structure shown in Figure 15, is shown in Figure 16. The horizontal bending crack advancing from the window on the right has progressed to the corner wall-wall junction area since there is no vertical beam. Corner failure mechanism was triggered as a result of in-plane and out-of-plane damage mechanisms, which occurred as a result of the deterioration of the structural integrity as a result of not making the beam at the roof level and directly supporting the wooden roof to the masonry wall.

Figure 16. Damage distribution in a single storey masonry building (38.35256 N, 38.31163 E) [17]

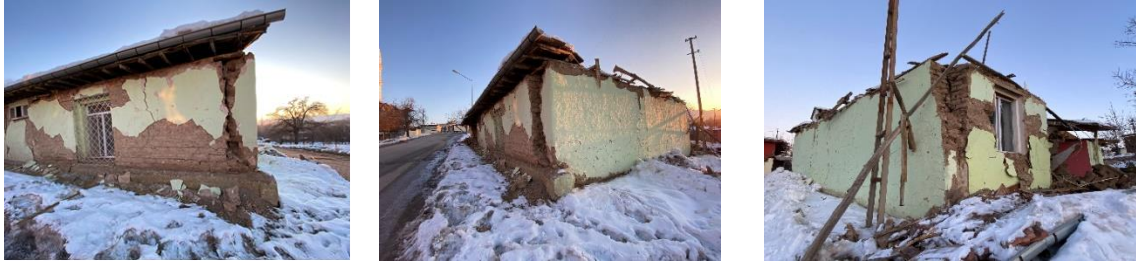
Figure 17. A masonry structure that combines the causes of the corner collapse mechanism (38.31279 N, 38.25054 E) [17]

The structure shown in Fig.17, on the other hand, is a masonry structure where the reasons for the corner failure mechanism are together. It has been determined that there is insufficient connection between the roof system and load-bearing walls in the building, which was built with adobe without any engineering service. The front wall of the building collapsed due to out-of-plane bending, which caused separations at the corner joint and the structure was heavily damaged. There are many examples of corner failure mechanisms given so far, and some of the failure modes in Gunduzbey neighborhood are presented in Fig.18.

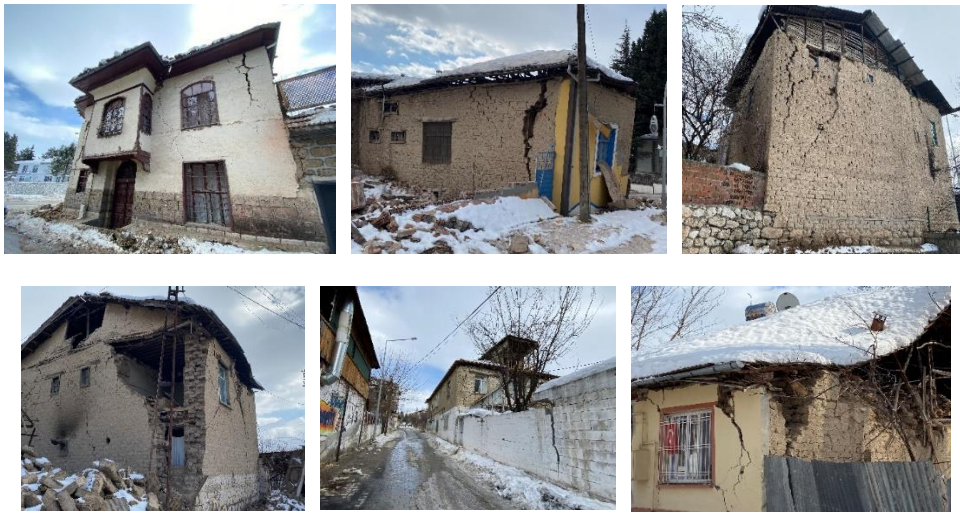
Figure 18. Corner failure mechanisms in masonry structures in Gündüzbey district [17]
