## DESIGN DEFICIENCIES AND FAILURE MODES IN REINFORCED CONCRETE STRUCTURES: THE CASE OF KAHRAMANMARAS EARTHQUAKE

**Abstract.** In Turkey, after two big earthquakes centered on Kahramanmaraş on February 6, 2023, a catastrophic damage occurred and more than fifty thousand people passed away, and a lot of people lost their comfort of life even though they were rescued from the rubble. It has been emphasized by scientists that this great destruction, in almost all types of structures such as concrete, steel, stacking and prefabricated, is usually caused by design errors, poor material quality and workmanship. In this study, design errors and damage modes of reinforced concrete structures in Malatya were examined with a field study. During the fieldwork, it was determined that reinforced concrete structures were generally damaged or collapsed due to inadequate longitudinal reinforcement and stirrup, poor reinforcement and concrete quality, design errors in the column-beam joint region (strong beam-weak column and lack of stirrup spacing), torsional irregularity, ignoring the soil-structure interaction and soft storey.

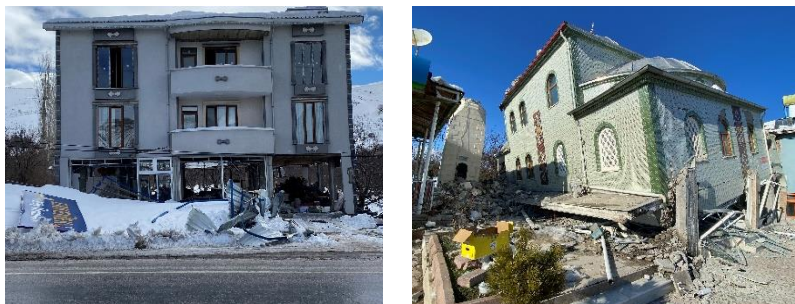
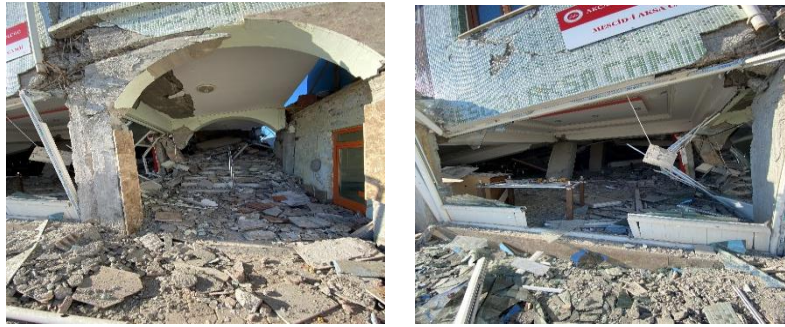
*Soft storey.* The difference in rigidity between the floors of the building creates a soft storey irregularity. It is desirable that the total displacement of the building be divided by the total floor height. However, if there is a floor with less rigidity, this floor displaces more and this floor is called soft storey. After the earthquake, the examinations in Malatya indicated that, one of the most common causes of collapse was the soft storey. Examples of structures damaged due to soft storey are shown in Figure 7.

**Figure 7.** Examples of damage due to soft storey [9]

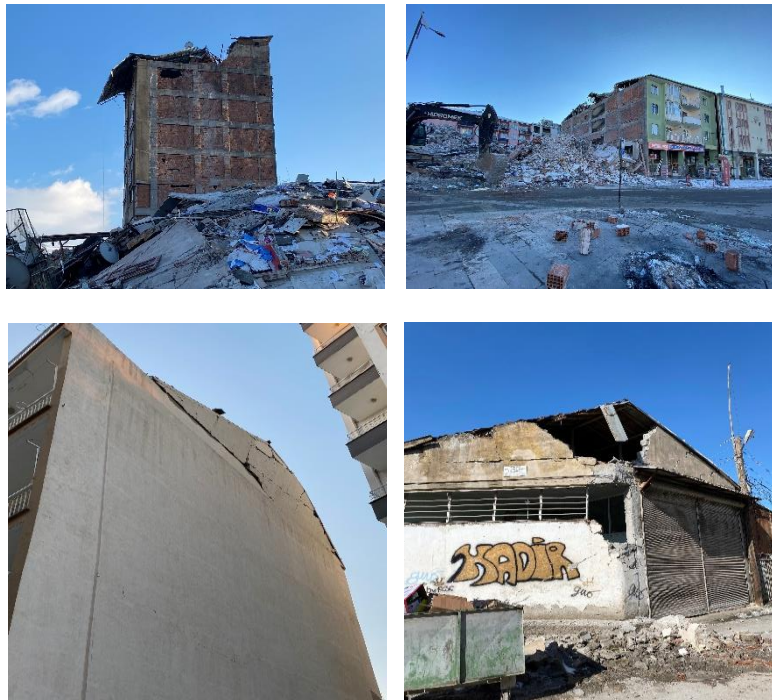
*Failures of gable walls.* Existing gable walls were weak against the out-of-plane mechanism during the earthquake because these walls were constructed without bond beams. This type of failure is not a structural damage but falling parts of wall can be cause loss of lives and properties. The main reason of damages to such walls is the large unsupported wall lengths. It was determined that poor wall-to-wall, wall-to-floor connections, and absence of lateral supporting walls were the other reasons of these damages [10]. The photos taken during the investigations after the earthquake in Malatya and the damage caused to the gable walls are shown in Fig.8.

**Figure 8.** Failures of gable walls in Malatya [10]

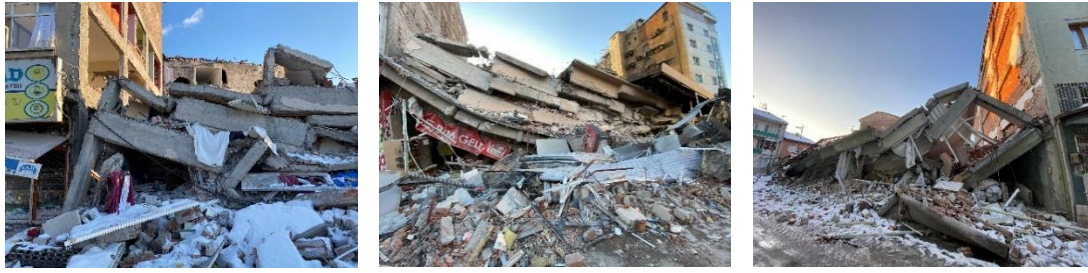
*Strong beam–weak column.* In reinforced concrete structures, the stronger design of the columns than the rafters is a very important design principle. Because the parts that are exposed to the most earthquake force with the moments that will occur during the earthquake will be at the column-beam junction points and the formation of plastic hinge will occur. The formation of these plastic hinges on the beams will prevent the structure from being heavy damaged and will allow it to consume more energy. However, during the field work, many strong beams and weak column combinations were observed by the researchers in the buildings that were heavily damaged and collapsed, and some of them were shown in the Fig.9.

**Figure 9.** Failures due to strong beam- weak column combination [10]

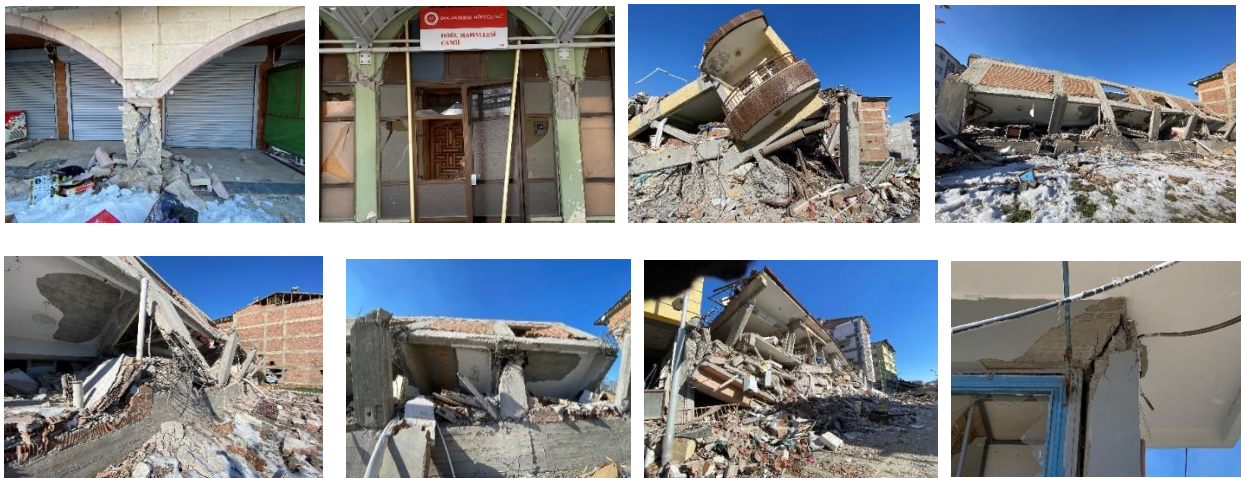
*Inadequate reinforcement.* Another design error determined in reinforced concrete structures in Malatya during the fieldwork is inadequate reinforcement. Examples of damages caused by this design error are shown in Fig.10.

**Figure 10.** Damages caused by inadequate reinforcement [10]

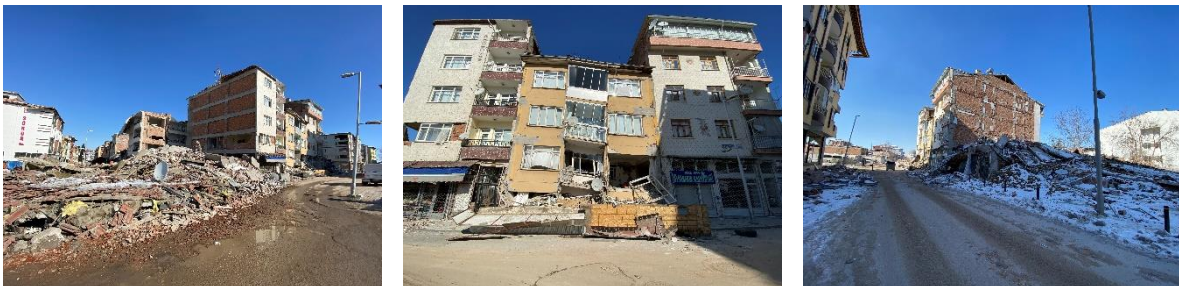
*Adjacent Buildings.* Adjacent buildings are frequently preferred in Turkey, especially in old settlements. If a building with insufficient seismic performance is located somewhere between adjacent structures, it can perform better than expected by getting support from other structures. Although this situation was encountered in Malatya, the opposite scenarios were also observed. That is, buildings that are individually modeled and resistant to earthquakes, without considering the effects of adjacent systems, are usually heavily damaged or collapsed if they are located at the outermost of the structures built as adjacent structures. A situation related to this is shown in Figure 11 with the buildings in the same adjacent order.

**Figure 11.** Examples of damage and collapse in adjacent structures [10]

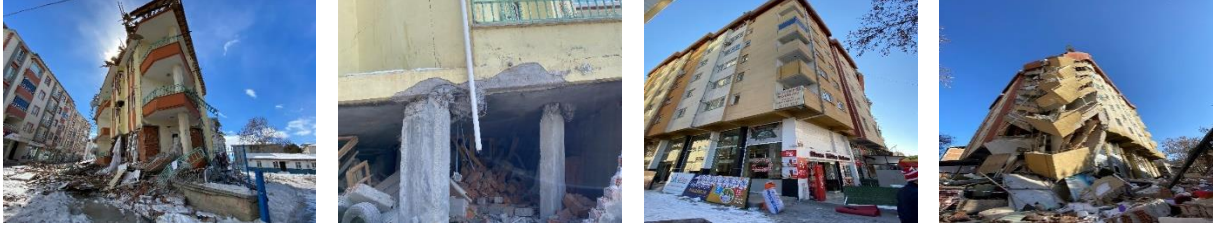
*Torsional irregularity.* Torsional irregularity occurs because the rigidity center and center of gravity of the structures do not overlap, or the limits given in the regulations are exceeded. This irregularity can often cause structures to collapse with heavy damage. Examples of torsional irregularities observed in center of Malatya and Doğanşehir (district of Malatya) are shown in Fig.12.

**Figure 12.** Examples of damages in structures with torsional irregularity [10]

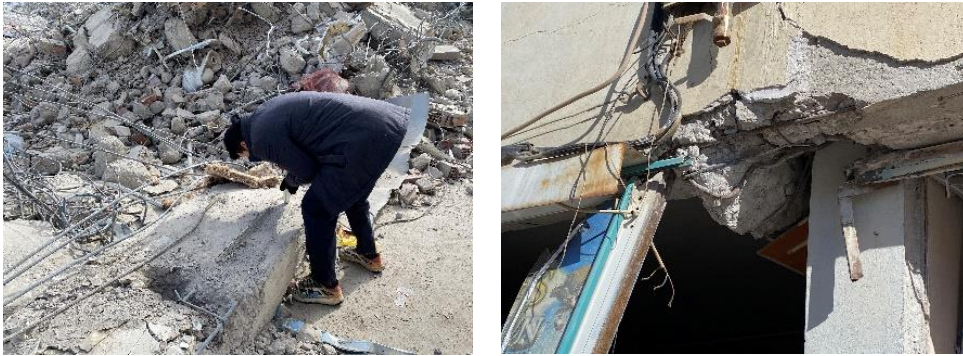
*Poor quality of materials.* During the fieldwork approximate compressive strengths were tried to be measured with schmidt hammer from the concrete in the reinforced concrete structures that were demolished. Generally, it has been determined that the compressive strength of concretes are below 10 MPa. As reinforcement, unribbed flat reinforcement is used and its tensile strength is 220 MPa. In addition, a decrease in cross-section due to corrosion was also detected in the reinforcements. Studies on material quality are shown in Fig.13.

**Figure 13.** Poor quality of materials [10]
