## FIRST-LEVEL SEISMIC RISK ASSESSMENT OF REINFORCED CONCRETE PUBLIC BUILDINGS CONSIDERING HILLTOP AND SLOPE EFFECTS IN SAMSUN, TÜRKİYE

**Abstract.** Rapid seismic risk assessment methods are critical for mitigating disasters in seismically active regions. This study presents the first-level seismic assessment methodology applied to reinforced concrete buildings within Samsun Province, Türkiye. The evaluation relies on a multi-parameter scoring system that accounts for structural typology, building age, and various architectural irregularities. By analyzing key parameters—such as soft stories, heavy overhangs, short columns, and pounding effects—this method provides a rapid, efficient framework for identifying high-risk structures. The findings provide a basis for urban resilience planning and prioritization of buildings requiring detailed seismic evaluation.

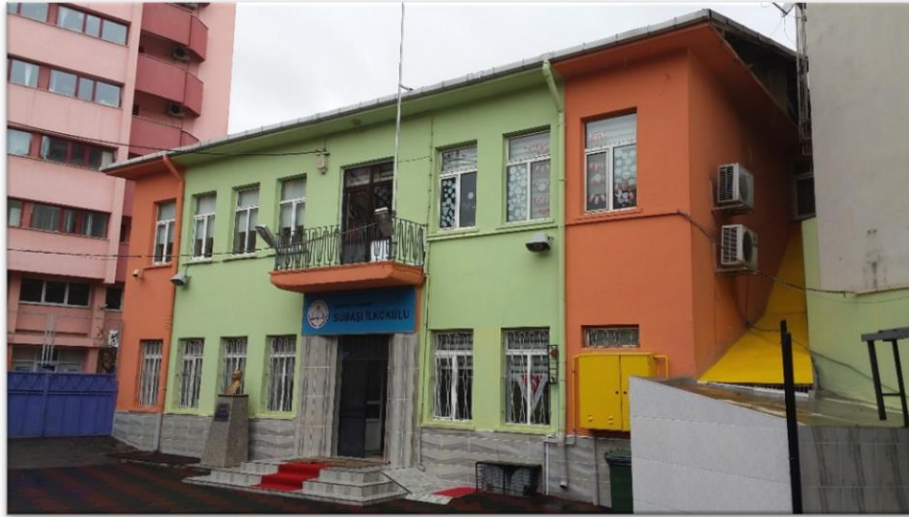
Since this study focuses on public buildings across the province of Samsun, 82% of the structures were evaluated as "good" in terms of visual quality, attributed to the regular execution of their annual maintenance and repairs.

**Fig.5.** A school building with regularly maintained exterior facades

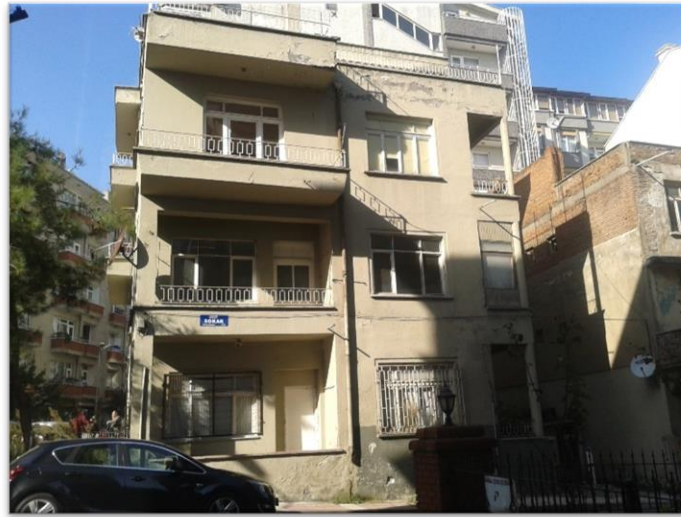
Considering the building age and the construction techniques employed (such as the non-utilization of ready-mixed concrete and ribbed rebars, or the usage of unwashed marine sand), public buildings constructed in 1997 and earlier are expected to be in a poorer condition than those built in 2000 and thereafter. However, since the supervision processes during the estimated cost estimation, tendering, and construction phases are executed by the technical personnel within public institutions, it has been observed that these buildings are in a better state in terms of visual quality and workmanship compared to the surrounding residential buildings of the same vintage.

**Fig.6.** Abandoned lodging buildings

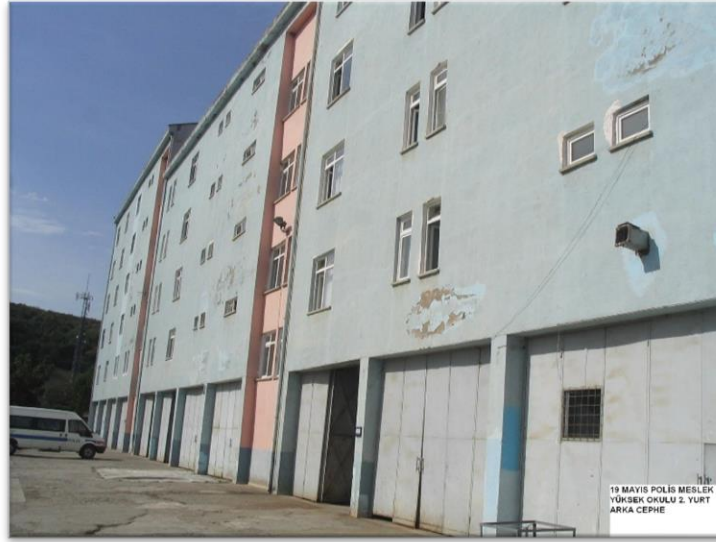
Since the structures examined in this study are public buildings, their ground floors are not utilized for commercial purposes; consequently, it was observed that 94% of the buildings were constructed in compliance with standard floor plans and storey heights. In contrast, it was noted that in certain public buildings such as police stations and hospitals, which require the accommodation of specially equipped vehicles, the ground floors were constructed with greater heights to serve as vehicle parking or washing bays. This architectural configuration led to the formation of a soft storey irregularity in 6% of the investigated buildings.

**Fig.8.** A public building with a ground floor utilized as a garage

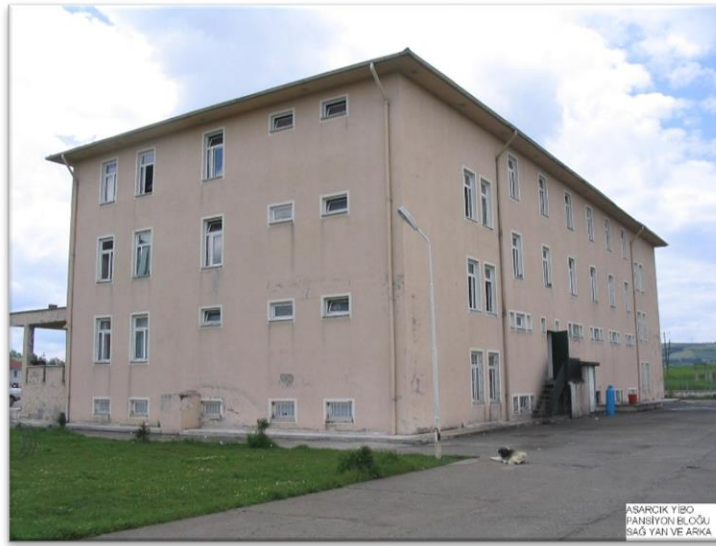
Since the structures examined in this study are public buildings with high occupancy rates—such as hospitals, schools, and dormitories—facilities including boiler rooms, indoor parking lots, and storage rooms are constructed on the ground and basement floors. Due to the installation of strip windows for natural lighting in these areas, the short-column effect was observed in 71% of the investigated buildings.

**Fig.10.** A school building with strip windows in the basement floor

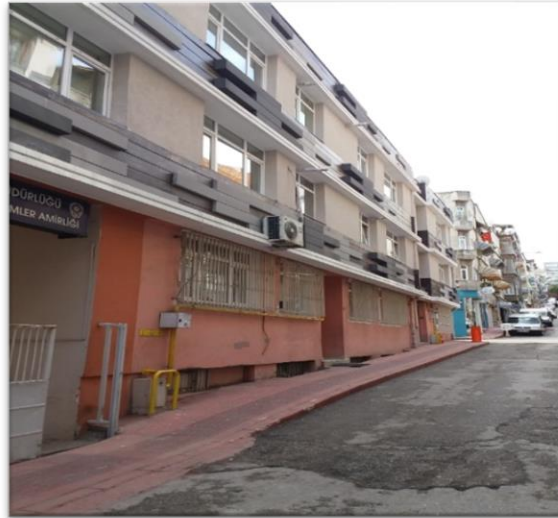
However, because the regional development characteristic is predominantly an adjacent layout, particularly in the downtown area of the İlkadım district in Samsun province, apartment-style lodging buildings belonging to various institutions in this zone were investigated regarding their joint spacings. Accordingly, it was observed that 62% of these buildings were constructed with adequate joint spacing; however, structures located in the relatively older settlements of the district in terms of urban zoning failed to satisfy the required joint clearance adequacy.

**Fig.12.** Adjacent building layout in Samsun city center

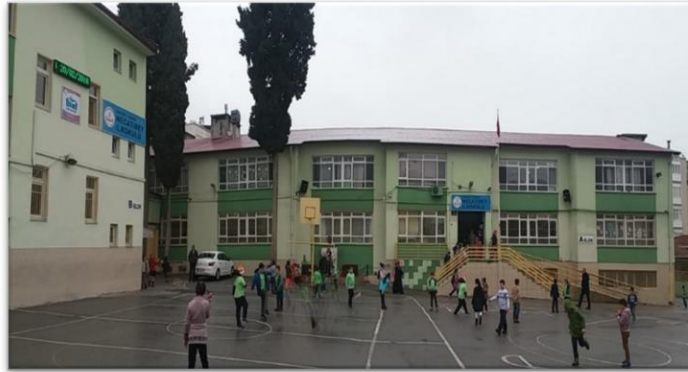
Public structures are planned not merely as standalone service buildings, but integrated with parking areas, yard spaces, additional service facilities, and outbuildings. Consequently, because multiple sections or buildings utilized for different purposes must be situated on single or multiple parcels, the land selection process for construction is executed by rigorously considering terrain conditions to determine the most optimal site. Therefore, it was observed that for the public buildings examined in this study, plots with a natural ground slope exceeding  $30^\circ$  were not selected.

**Fig.13.** A school building planned with its own yard

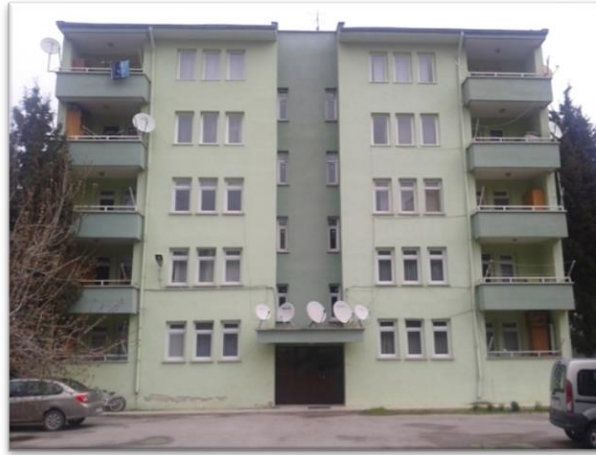
The observations recorded under the "Heavy Overhangs" parameter are also valid for the "Vertical and Plan Irregularities" parameter. Public structures built prior to 1997 were constructed in accordance with standardized type projects, such as lodging facilities, dormitories, hospitals, and 8-classroom schools. In these low-rise type buildings, no plan or vertical irregularities were observed; furthermore, it was noted that bridging large spans for areas such as conference halls and gymnasiums without proper column and beam support was meticulously avoided. For public buildings constructed after 1997, the cross-sections of the structural system components were selected in strict compliance with the revised and updated seismic codes. Notably, investigations carried out on public structures built after 2000 revealed no evidence of plan irregularities.

**Fig.14.** A lodging building constructed in accordance with standardized public building type projects
