## NON-DESTRUCTIVE AND SEMI-DESTRUCTIVE TESTING FOR SEISMIC RISK ASSESSMENT OF PUBLIC BUILDINGS: FIELD FINDINGS FROM SAMSUN, TÜRKİYE

**Abstract.** This study evaluates the seismic risk of 406 reinforced concrete public buildings located across 17 districts in Samsun Province, Türkiye, within the framework of Law No. 6306. A multi-level assessment approach combining rapid visual screening and selected non-destructive and semi-destructive testing techniques was implemented. These included reinforcement detection using Ferroskan technology, localized concrete cover removal, and Schmidt rebound hammer testing. The buildings were classified into five risk categories based on structural performance scores, resulting in 14 buildings identified as first-degree high risk and 48 as second-degree risk requiring priority intervention. The remaining structures were distributed across lower risk categories, indicating varying levels of vulnerability. A regional database was developed to support continuous monitoring and risk prioritization of public infrastructure. The findings suggest that, under updated seismic code provisions introduced in 2019, several of the assessed buildings may exhibit

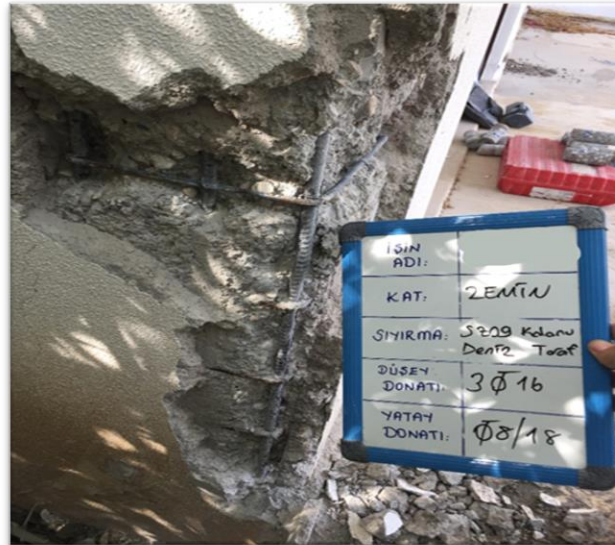
**Fig.4.** Concrete chipping process in columns

As a result of the concrete chipping process, it was concluded that the reinforcement diameters utilized in the columns were adequate, and the corrosion rates occurring in the reinforcement were within reasonable levels. The inspection revealed that stirrup confinement was not implemented at the column

ends only in the reinforced concrete buildings constructed in 1997 and earlier; the stirrup spacing varied between 20 and 30 cm along the column length, and consequently, the transverse reinforcement elements were found to be insufficient.

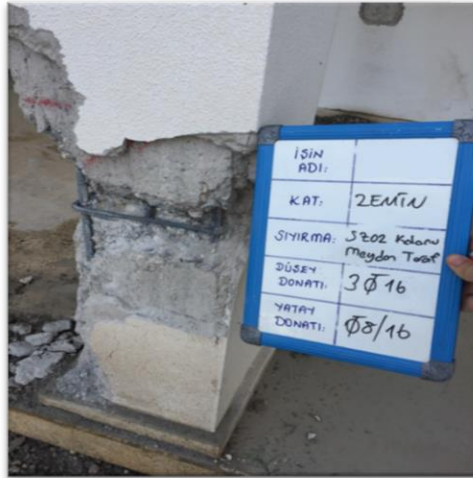
**Fig.5.** Concrete chipping process in columns

In the now-defunct residential buildings where concrete chipping was performed for reinforcement detection, results suggest that plain (smooth) rebar was used in some columns, and the reinforcement diameters selected during construction were incompatible with the column dimensions. Furthermore, within the critical confinement zones located at the end regions of columns and beams, observations indicate that the poorly cast concrete underwent segregation as a result of insufficient concrete curing and faulty workmanship, and the concrete quality was low.

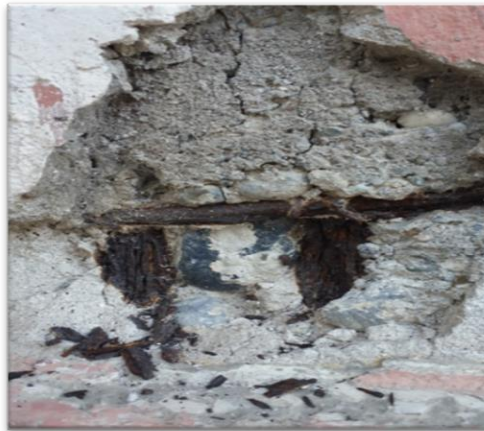
**Fig.6.** Corrosion in column reinforcement
