DESTRUCTION, RECONSTRUCTION, RESTORATION: FROM THE “PROJECT OF KNOWLEDGE” TO MONUMENTS’ CULTURAL AND MATERIAL RETURN TO COMMUNITIES: STUDY CASES

THE RESTORATION OF THE XV CENTURY AREZZO FORTRESS

INVESTIGATIONS AND RESTORATION PROJECT OF THE CITY WALLS OF SUZHOU- CHINA. The activities that led to the understanding of the state of conservation of the walls of Suzhou, in the Panmen area (Fig. 33), were conducted starting from July 2019 with a survey campaign that involved a group of Italian specialists, coming from Florence University and private companies with the collaboration and support of Chinese technicians and professors.

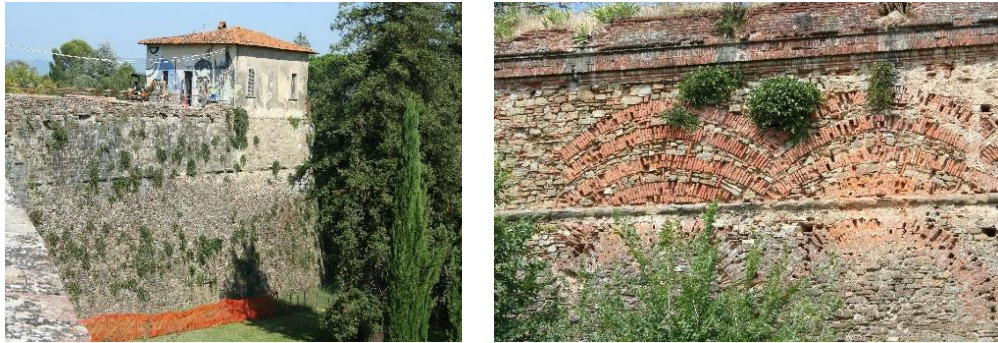
Figure 3, 4. The Fortress before the exterior walls restoration project

The first restoration phase of the Fortezza. The restoration of the Fortezza's external facings, carried out between 2008 and 2011, was an extraordinary application of stone restoration criteria and techniques (Fig. 3,4), starting from a survey carried out with laser-scanner technology (Fig. 5,6) and a careful diagnostics program (Fig. 7,8,9).

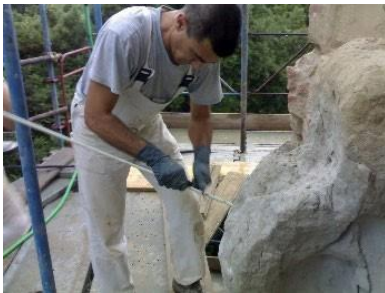
Figure 10.

Low pressure water cleaning of the walls

- Cleaning operations were carried out: dry cleaning to eliminate particles, dust and guano deposits, removed with brushes; cleaning stable stone surfaces with low pressure de-ionised water with water jets with rotating heads (Fig. 10) selective cleaning of stone surfaces in the areas where deposits were thicker, more compact with distilled water and a saturated solution of ammonium carbonate (Fig. 11,12).

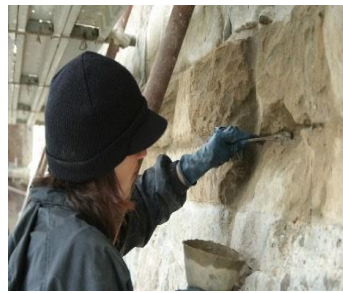
Figure 11.

Manual filling of cracks and joints

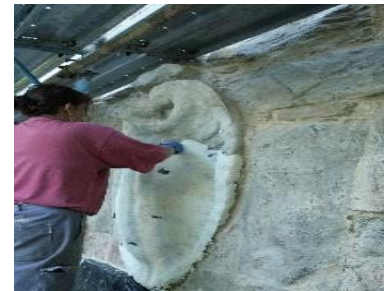
Figure 12.

Selective cleaning with ammonium carbonate

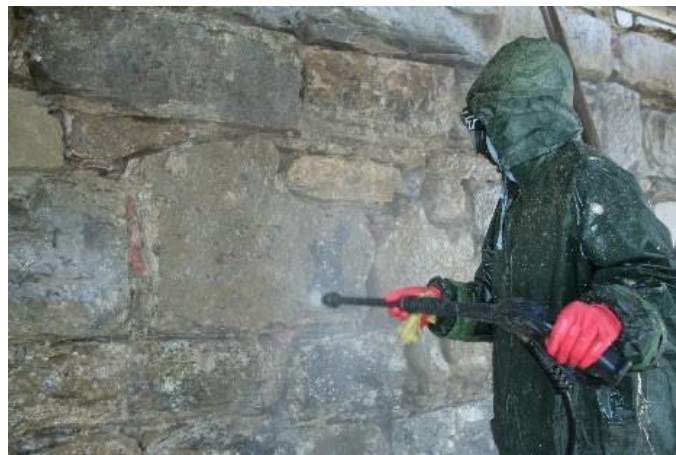
Figure 13. Consolidation with fiberglass bars

Specific consolidation work was carried out: consolidation of fragments, after pre-consolidating them with ethyl silicate, with epoxy resin and by inserting fiberglass pins (Fig.13) consolidating fractures by inserting stainless steel pins and injecting pressurized fluid epoxy resin; indenting masonry to mend specific lesions with the same stone as the existing one, filled with a suitable mortar.

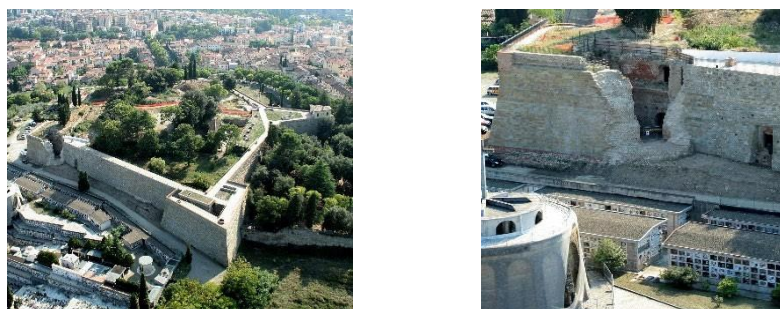
Figure 19, 20. The Fortress after the restoration of the external walls, aerial views (end of phase one)

Following the restoration work initially carried out by means of specialized works on the curtain walls, complex and delicate conservative operations have been conducted on the ramparts as well as the open spaces inside the Fortress (Fig. 19, 20).

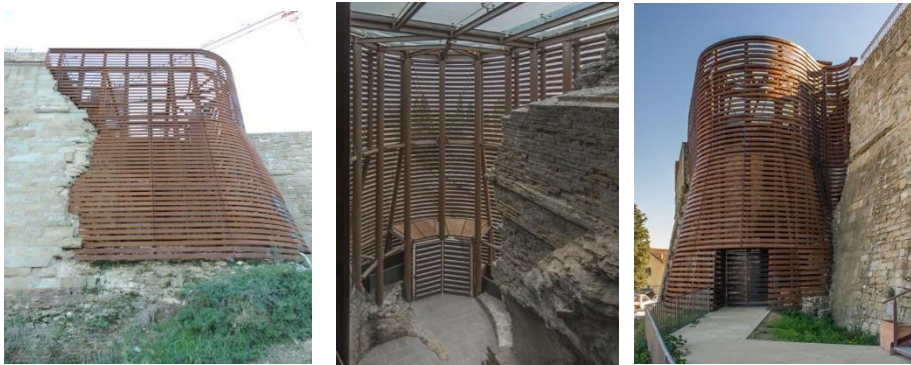
Figure 24, 25, 26. The “Belvedere Bastion” destroyed in 1800 by the Napoleon troops, reconstructed as a contemporary architectural addition referring to an historicized loss

The restored Bastions develop into a cultural mission. On the one hand, therefore, the Fortress rooms inside the visible and measurable bastions had to be preserved in all their components, operating the necessary albeit rare structural reinforcement operations, and maintaining each integral part in the single rooms as evidence of a building style and concept of fortified spaces, as well as stopping the degradation without making renovations. The planned use required designing easily reversible and low-maintenance technological equipment. Functional needs, regulatory and comfort requirements that would let people enter and spend time inside the Fortress highlighted the need for interaction between pre-existing parts and new additions. Regarding the work carried out on the ramparts, the spatial system that typifies the cultural use of the Fortress of Arezzo finds a particularly significant example in the Soccorso bastion on how to reorganize entrances and exits as well as the use of the building and its dedicated areas. This architectural addition establishes an unprecedented dialogue between ancient and recent architecture through the contemporary language of newly built heart-shaped portion of the bastion, which collapsed under Napoleonic mines in 1800. The Soccorso bastion is also a new entrance to the Fortress; the figurative re-composition of its geometry, without concealing the original loss of continuity, bridges the gap from a formal point of view and reverses the sense of traditional impenetrability that is typical of defensive buildings: the new curtain wall allows for controlled transparency at night as well as in daytime (Fig. 24, 25, 26).

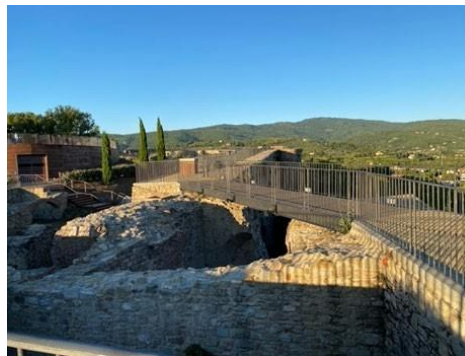
Figure 27. A new bridge over the “Belvedere Bastion” destroyed in 1800 by the Napoleon troops

Recent restoration work on the Belvedere bastion included an additional entrance to the Fortress stopping and consolidating the materials and masses shattered over the course of two centuries, linking internal paths with walkways, stairs and aerial bridges and reconstituting the walkway (Fig. 27). The monument has therefore become accessible to thousands of people who are attracted to the place and attend various cultural events.

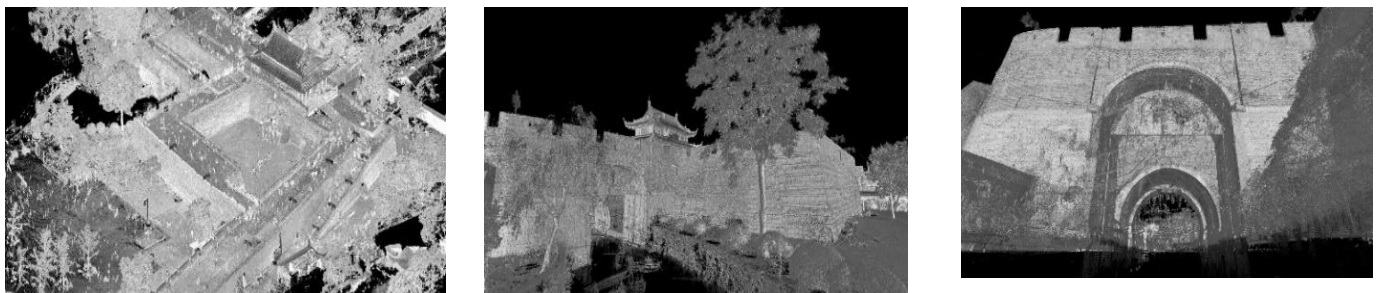
Figure 34, 35, 36. The laser-scanner survey of the Panmen area

The digital survey. The digital survey of the Souzhou walls has been structured in two main parts: 3D laser scanner survey and photogrammetry (Fig. 34, 35, 36). Both the operations took about seven to 10 days to be completed.

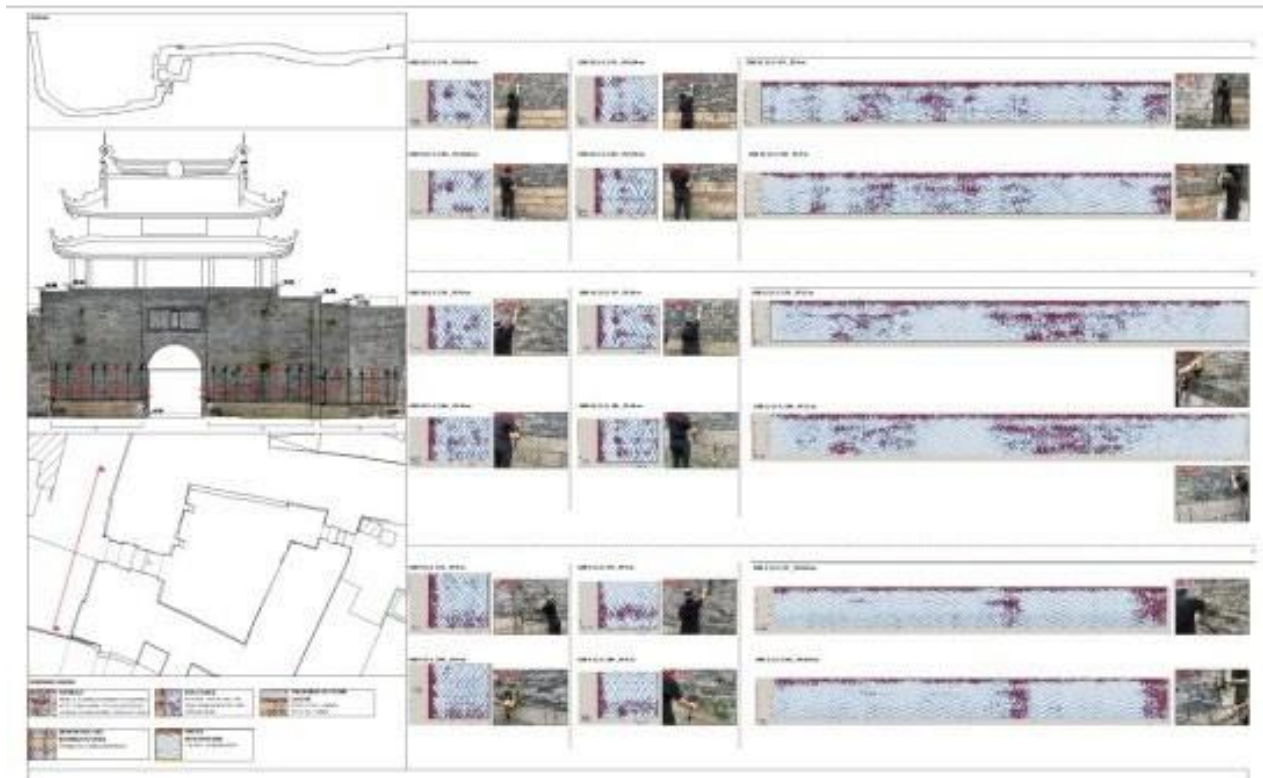
Figure 40. Results of the Georadar investigations

Geophysical surveys at the Suzhou Panmen historical area The Team conducted a non-destructive investigation (3D ERT and GPR) of the structures of the Panmen gate and surrounding ancient city walls, aiming to: investigate the internal core of the ancient masonry (Fig.40), reconstruct the stratigraphy under the foundations of the accessible structures, identify the presence of heterogeneities in the ancient wall structures and/or in the soil below their foundation, correlate them with the visible settlements, assist the work of restoration experts with information relative to the type of construction and extent of foundations.

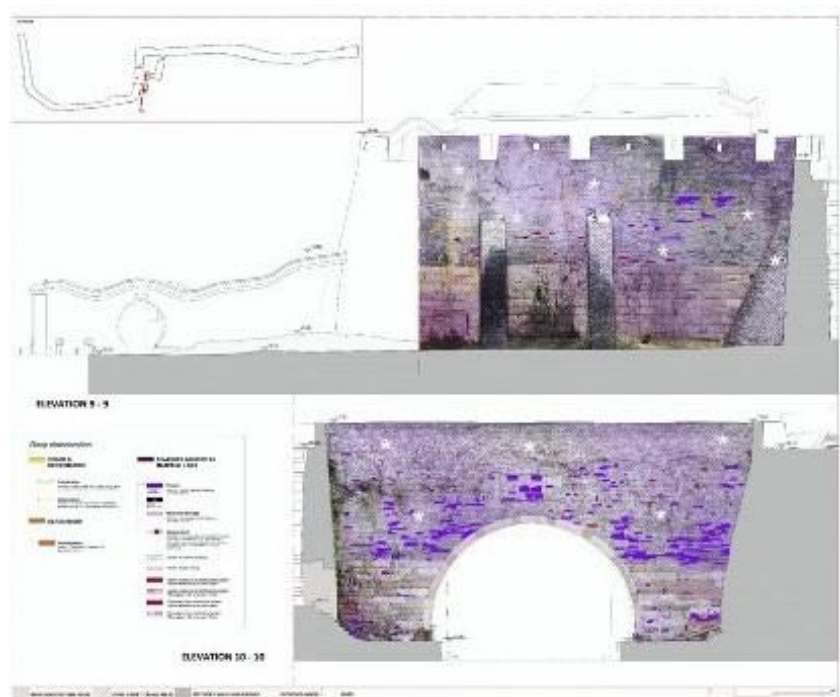
Figure 43. One of the decay analysis and restoration project boards on an orthophoto

Legend of project intervention. On the basis of previous experiences in Italy and internationally, the following various restoration interventions have been identified and reported on the drawings that make up the restoration project (Fig. 43).
