THE CURRENT DISCOURSES IN PRESERVATION AND PRESENTATION OF ARCHAEOLOGICAL HERITAGE

Mine Tanaç Zeren- faculty of Architecture, Dokuz Eylül University İzmir, mine.tanac@deu.edu.tr Turkey

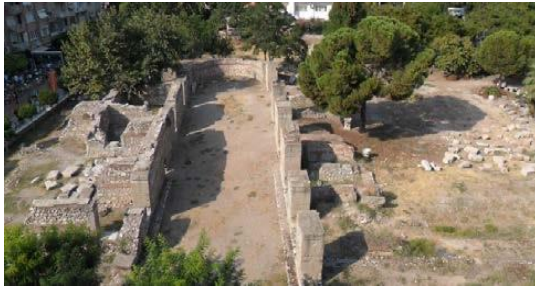
Figure 1. Apsidal Building Remain
(Tanac Zeren Archive)

In the ruins of Tepe Mezarı, the building remains were first found in the excavation pit opened by the Forestry Administration in 1962 (Doyduk, 2003, p.49). Then, between 1968 and 1971, archaeological excavations were carried out by the archaeologist Rüstem Duyuran. As a result of the excavations, the traces of the structure identified as a basilica without a religious function dating from the 2nd to the 6th centuries AD and a portico from the 2nd to the 4th centuries AD were found at the site (Akdeniz, 2013, p.432). At the end of excavations, a main building extending in the north-south direction and other connected structures surrounding this main building were uncovered. At the center of these structures stands the main building with a rectangular plan and an abscissa in the north side. (Figure 1) The preserved structure is 10 meters in width and 48 meters in length from the abscissa. The actual length of the southern section cannot be determined, since it remains beneath today's modern street and buildings. The walls of the monumental

building were made of rubble stone, lime and sand mixed mortar and its height was preserved up to 4 to 5 meters (Akdeniz, 2013, p. 433).

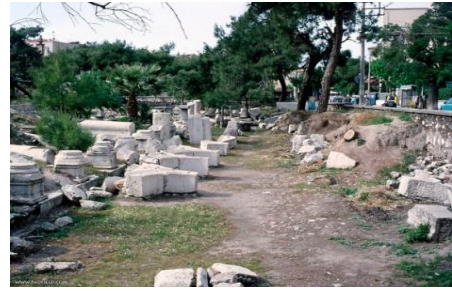
Figure 2. Remain of Roman Columns
(Tanac Zeren Archive)

Another ruins unearthed as a result of the first period excavations are a portico and a colonnaded Roman street extending in the north-south direction to the west of the ruin (Figure 2). The street in front of the portico; It was found covered with a floor made of small rubble stones. From the ruins; It was found that the street belongs to the Roman Period and is surrounded by rows of columns on both sides (Duyuran, 1974, p.19)

All the portamentos found in this area are in-situ, as well as all the other parts on top of them according to their state at the time of collapse. In this street, the stylobate blocks of the colonnade, consisting of two rows, are placed on a foundation made of rubble stone with sand and lime mortar. Most of the capitals in-situ in the colonnaded road and portico are in the Ionic order and some of the capitals in the northern part of the area have a Corinthian order (Duyuran, 1974, p.18). These were temporarily placed on pedestals and exhibited in the ruins.

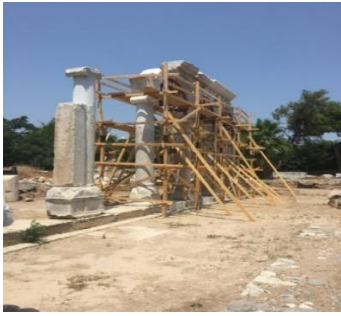
Figure 3.
The Stylobat(Tanac Zeren Archive)

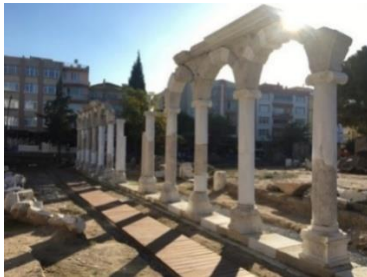
Figure 5.
The Anastylosis Work of Columns
(Tanac Zeren Archive)

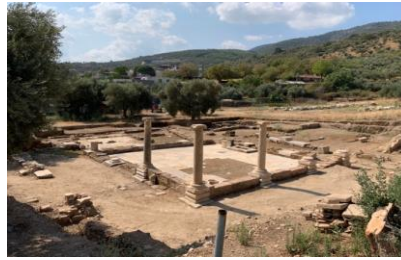
Figure 9. The current position of the Peristyle House

The Anastylosis works in Metropolis Ancient city done aiming firstly protecting the Archaeological Assets, secondly to present them to the visitors on sight more properly. The Anastylosis of the three columns of the Peristyle House is done just to define the square courtyard of the Peristyle House more properly to the visitors. The figure 10 is showing the situation of before Anastylosis application, and the figure 9 shows the current situation. A restoration work is done as well for the Bouleuterion Building and the Byzantine Fortification Wall. As shown in the figure 11 and 12 the fortification wall dating back to Byzantine Period is built on the center of the Cavea of Hellenistic Period Bouleuterion Building. After the excavations of the Bouleuterion Building it is aimed to make the very well preserved Cavea of the Bouleuterion Building visible, and accessible by both preserving the togetherness of the two ancient periods, the Bouleuterion and the Byzantine Fortification Wall. For this purpose; the part of the wall locating just upside part of the Orchestra space of the Bouleuterion building is consolidated, and some stone blocks are removed, and a passage is produced. By this passage the perception of the two equal sides of the Cavea beneath the Fortification wall is managed to be detected. This passage also has a role to direct the Visitors through the Bouleuterion Building to the Stoa of the city (Figure 13,14).

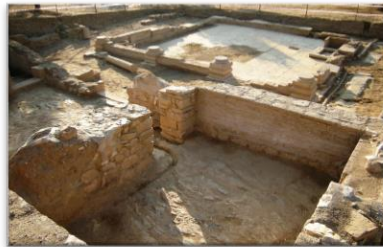
Figure 10. Peristyle House before Anastylis (Tanac Zeren Archive)

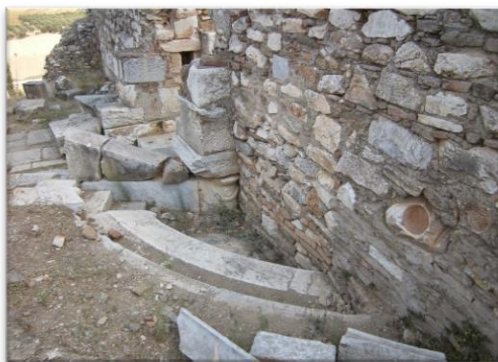
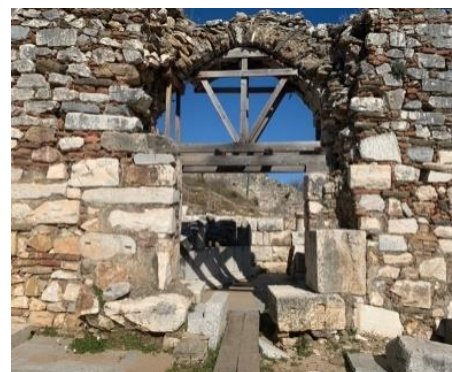
Figure 13.
Photo showing the Cavea of Bouleuterion
under the Byzantine Fortification Wall

Figure 14.
The Passage (Tanac Zeren Archive)

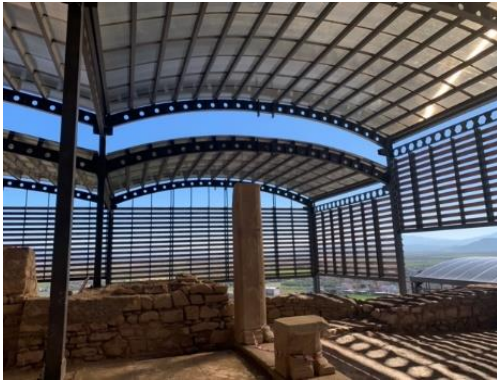
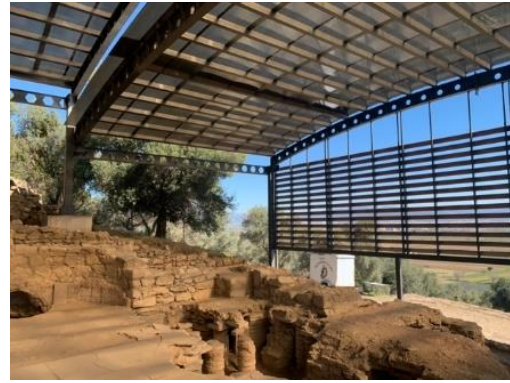
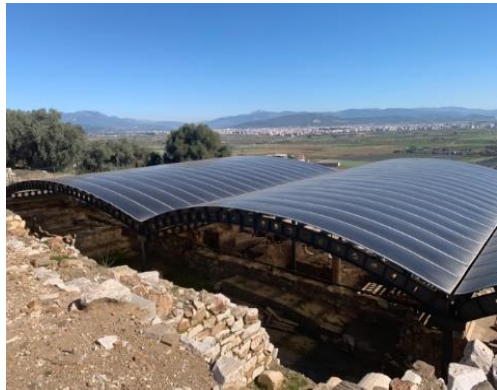
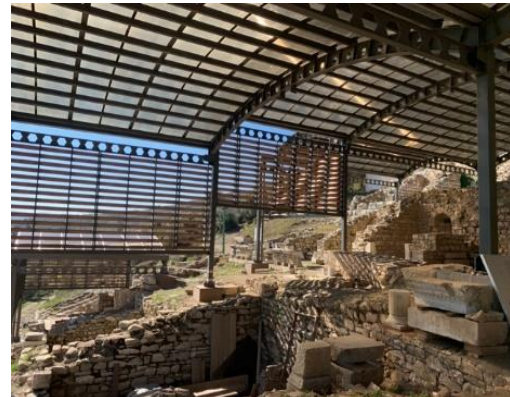
Fig.15,16 The Protection Roof placed on the Roman Bath Ruins in Metropolis (Tanac Zeren Archive)

Figure 17, 18. The Protection Roof placed on the Roman Bath Ruins in Metropolis (Tanac Zeren Archive)

The shelter of the upper Roman Baths; will be given as an example for this case which is made completely reversible with new materials and new structural system elements aimed to respect and provide the interpretation of the authenticity and spirit of the site both with its natural and manmade elements by not causing any evidence and value loss of the archaeological monument. The roof has a gridal structural system, the pillars are very thin and none of them damage the remains underneath or around the protected area. The foundations are hidden. (Figure15-16-17-18) the roof is also integrated accessible informative aids, such as plans, details, figures, texts, etc. in order to support every visitor's understanding and comprehension of the site and its surroundings.

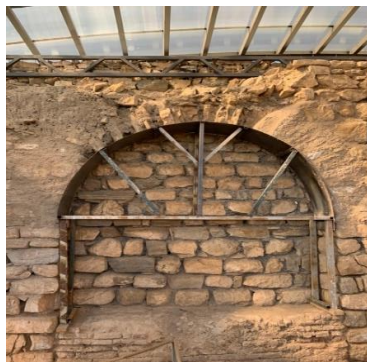
Figure 19.
Consolidation of an Arch in order to preserve and present the Architectural assets,

To support the presentation idea, some small mapping works and anastylosis works of the arches have been done after the excavation period. The Arch's were consolidated and mapping is applied on the surface the consolidated Arch's (Fig.19, 20). The floor coverings are reorganized on the floor on a membrane applied in situ. Some anastylosis works such as marble façade coatings were gathered to give an idea to the visitors about the wall finishing's of the Monument (Fig. 21, 22).

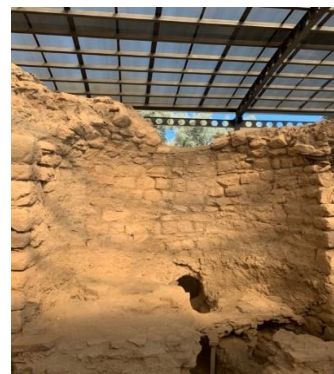
Figure 20.
Some mapping applications both on the façade of the consolidated arch and the dome (Tanac Zeren Archive)

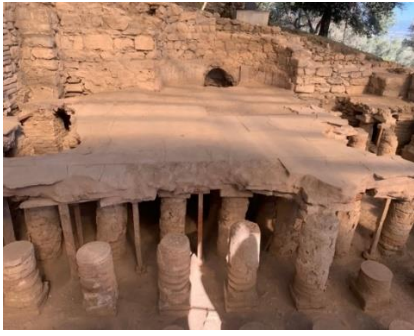
Figure 21.

Consolidation of the hypocaust System of The Roman Bath by using membrane and reorganizing the original floor coatings

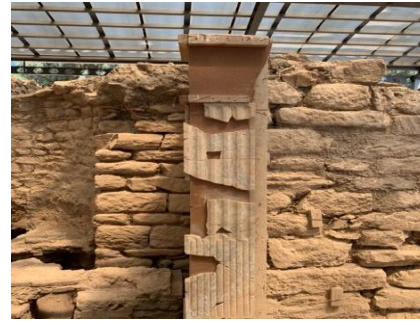
Figure 22.

Anastylosis work of the marble parts of the wall (Tanac Zeren Archive)

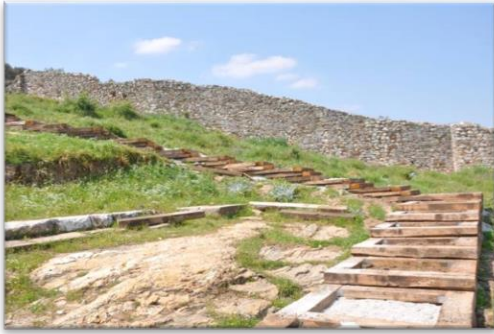
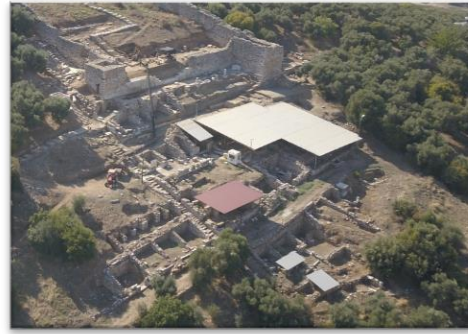
Figure 23, 24.

The walking Platforms of the city (Metropolis Excavation Archive)

All the Archeological Ruins on site are combined with each other with walking platforms. The walking platforms of the city is made of wooden material in harmony with the nature and the Archaeological ruins.

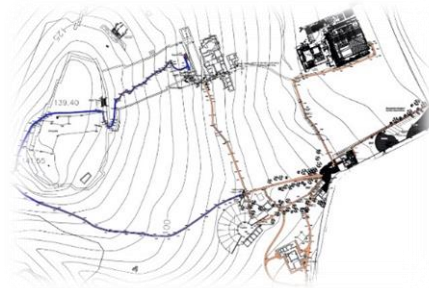
Figure 25.

The Organization of the walking platforms on site (Metropolis Excavation Archive)
