PERFORMANCE EVALUATION OF BASE ISOLATED HOSPITAL BUILDINGS AFTER KAHRAMANMARAS EARTHQUAKES

Abstract. The devastating effects of February 6th, 2023 earthquakes have been documented for many types of building systems located in the disaster region. Another important aspect of the region is that there are several seismic base-isolated hospital buildings that were constructed or is under construction. In this study, the performance evaluation of the base-isolated hospital buildings is discussed based on the data gathered from a field study conducted after the earthquakes. Several conclusions regarding the seismic performance of the isolator devices and behaviour of the isolated superstructure are made from these observations.

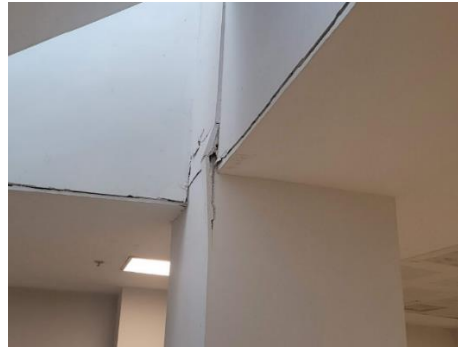
Base-isolated building performance. Elbistan State Hospital. The distance of Teflon slider markings from the isolator core was measured as 15 mm on one plate of friction pendulum isolator. In total, isolator displacement is computed as 30 mm. It has been observed that seismic isolators which are located at the basement story of the hospital are covered with gypsum boards to provide insulation from fire (Fig.1). Limited damage in these gypsum boards were observed in all column axes due to isolator movement. Upon closer inspection of a friction pendulum by removing the damaged boards, a residual displacement of 20 mm was measured between top and bottom plates of the isolator (Fig. 2).

Figure 1. Cracking and slight damage in gypsum boards covering the seismic isolators due to displacement during the earthquakes [10]

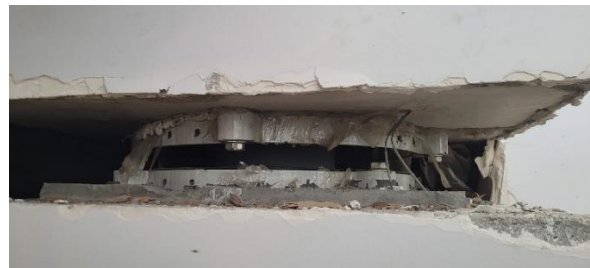
Figure 2. One of the friction pendulum type seismic isolators of Elbistan State Hospital [10]

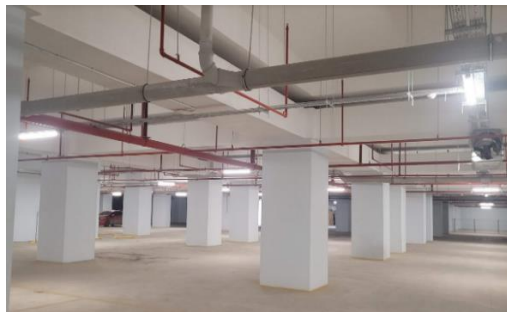
Seismic isolators are located at the parking story of the hospital building. Accurate measurements were taken from the elevator core isolators which are located at a lower elevation than the rest of the isolators. A very rigid framing is present at the isolator interface both for the superstructure and fixed portion. Upon closer inspection of the parking story, a well-designed seismic detailing for mechanical and electrical installations was observed (Fig.4). No apparent deformation or damage was noted in these installations.

Figure 4. Seismic detailing of mechanical and electrical installation at the parking story [10]

- A proper seismic detailing of electrical network and plumbing at the isolation story is of significant importance so no interruption of service occurs after the earthquakes due to failure in these installations.

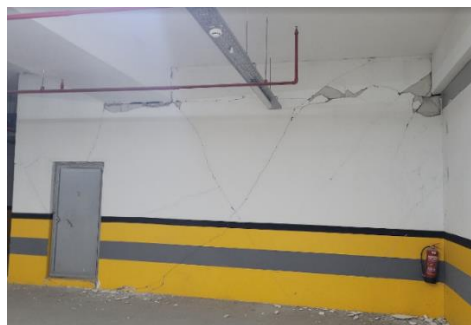
Malatya Maternity and Children Hospital. The hospital building is in Yeşilyurt district of Malatya city center. The displacement capacity of the isolators installed in the project is ± 360 mm. The maximum displacement computed from the slider marks on the isolator surfaces is 30 mm. No residual displacement is observed. Several issues have been detected in and around the hospital building constraining the movement of the isolated superstructure, hence the reason for low measured displacement.

The seismic isolators are located in the parking story of the structure. Upon inspection of the story, it has been discovered that infill walls were constructed to create rooms. There was no seismic detailing in these walls, as they were connected to the bottom slab of the isolated superstructure. Consequently, isolator movement has been severely constrained during earthquake response due to pounding effects between the bottom floor beams of the superstructure and the infill walls. Significant damage has been observed in these walls (Fig.5).

Figure 5. Infill walls at the isolator (parking) story, constraining the movement of the isolated superstructure [10]

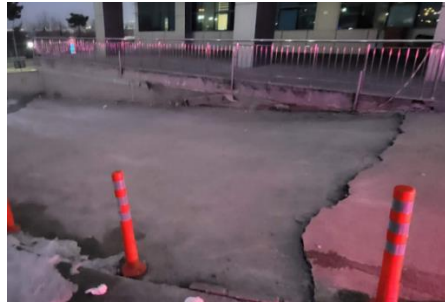
Several access ramps were constructed around the building perimeter, further constraining the displacement of the superstructure. The ramps were built using cast-in-place concrete with asphalt overlay. They provided a rigid connection between the isolated superstructure and ground, resulting in a limited isolator displacement response (Fig.6).

Figure 6. The access ramps of the hospital building cracked and deformed in places where the seismic gap would have been [11]

- Landscaping applications that include filling or closing the seismic gaps around the isolated structure affect the isolator performance negatively such that it yields to damage which could leave the hospital out of service.

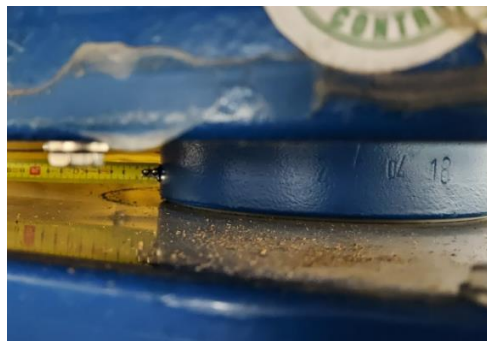
Hatay Dörtyol State Hospital. The hospital is in Dörtyol district of Hatay province. The design displacement of seismic isolators of the Hatay Dörtyol Hospital building ± 400 mm. The maximum isolator displacement has been computed as 40 mm (Fig.7), with no residual displacement. Although the hospital is in close proximity to the fault rupture of the first earthquake occurred on February 6th, evidence of minimal isolator displacement has been observed. A significant factor for reduced demand could be that the hospital along with Dörtyol district is located on stiff soil. The structure has well-constructed seismic gaps detailing along its perimeter (Fig.8). The gap is covered by hinged platforms that are connected to the isolated superstructure. The free end of the platforms has an angled detail that allows for sliding movement along the contact points to the pavement around the structure. No major damage has been observed in the seismic gaps apart from one corner that collided with the pavement during the earthquake action. It is determined that the resulting superficial damage did not constrain the isolator displacements (Fig. 9).

Figure 7. Measured isolator bottom plate displacement at Hatay Dörtyol Hospital [11]

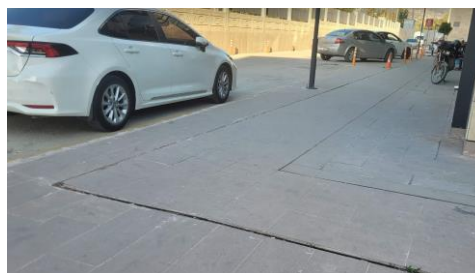
Figure 8. The hinged platform covers of the seismic gaps along the perimeter [11]

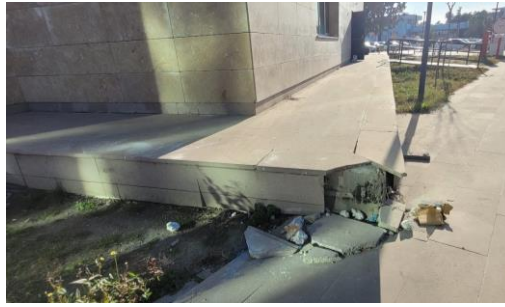
Figure 9. Minor collision damage between a corner of the isolated structure and the pavement [11]

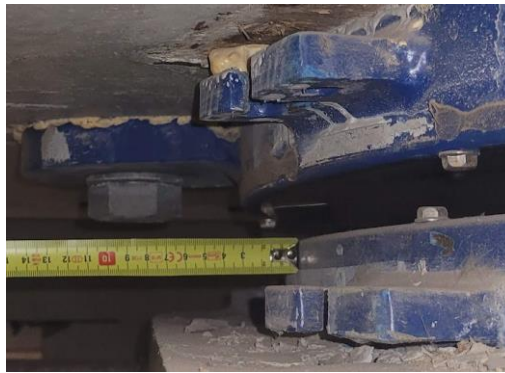
Osmaniye State Hospital. The hospital complex which was due to open one week after the February 6th earthquakes is in Osmaniye city center. The maximum isolator displacement has been computed as 60 mm. The isolators, which have a design displacement of ± 450 mm, exhibited 25 mm of residual displacement (Figure 10). No significant issues were detected at seismic gaps surrounding the structure and the isolation story. Hence, seismic isolators were not constrained during the earthquake response. A passive displacement measuring device composed of a marked plate and a needle was present at the isolation story (Figure 11). However, it did not measure the displacement demands of the earthquakes correctly.

Figure 10. Residual isolator displacement in Osmaniye State Hospital [12]

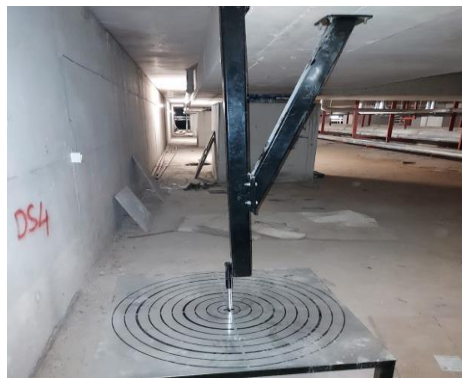
Figure 11. Displacement measuring device located at the isolation story of Osmaniye State Hospital [12]

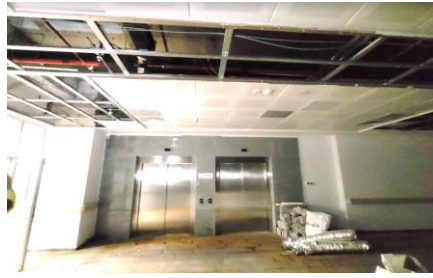
Some nonstructural damage in stairwells of the isolated superstructure was determined. More importantly, the fire suppression system has failed due to seismic action flooding several floors (Fig. 12). Due to inappropriate seismic detailing, the plumbing could not resist the earthquake induced displacement. Hanged ceilings and electrical components were found to be damaged due to flooding. If the hospital had been operational at the time of the earthquakes, it would have been out of service for several days due to flood damage.

Figure 12. Flood damage at upper stories of isolated superstructure and resulting red (rust) residue at Osmaniye State Hospital [12]

- Appropriate seismic design of the installations at the isolated hospital building is necessary for uninterrupted service after an earthquake. Hanged ceiling components, electrical connections, fire suppression systems should be designed according to expected seismic demands of the superstructure. It has been documented that the hospital could be taken out of service due to failure in these systems even though the structure survives the earthquake with no or minor damage.
