## EXPERIMENTAL STUDY ON OUT-OF-PLANE BEHAVIOUR OF MASONRY WALLS STRENGTHENING WITH CARBON FIBER REINFORCED POLYMER SHEETS

**Abstract.** In this study, the out-of-plane failure mechanism of medium-sized masonry panels, which is frequently encountered during earthquakes, is discussed. Four of 100 mm x 410 mm x 1200 mm masonry panels were fabricated for the experimental study. Solid brick with dimensions of 50 mm x 100 mm x 200 mm was used in the production of the masonry panels. For mortar, repair mortar was used for ease of production. Three of the test specimens were strengthened with carbon fiber reinforced polymer (CFRP). The number of strips and the way of applying strips were adopted as test parameters. Panel specimens were tested under the effect of bending, applying three- point loading. During the experiments the measurements of load, displacement and strain were taken. Behaviour of the masonry panels were assessed in terms of ultimate load, the displacement corresponding to the ultimate load, stiffness and energy dissipation capacity. According to the results obtained, it is concluded that the strengthened masonry panels are quite successful against the out-of-plane failu

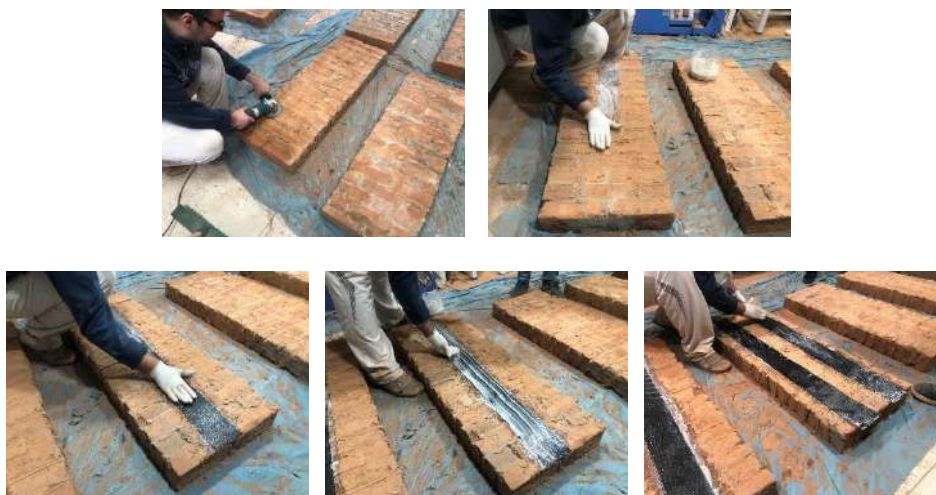
**Figure 5.** Strengthening processes of masonry panels [30]

Strengthening details of the test specimens were shown in Figure-4 The properties of CFRP and two-component epoxy used for strengthening were given in Table 3. Strengthening stages were shown in Fig. 5. The surface on which the strip would be bonded was smoothed by a machine to remove protrusions. Then, compressed air was applied to the surface and dust was completely removed from the surface with a wet cloth. After the position of the strip was marked, the two-component epoxy was applied to the wall surface and the CFRP strip was placed onto the epoxy by hand pressing. Finally, another layer of epoxy was applied on the strip.

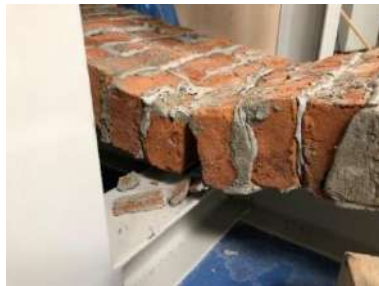
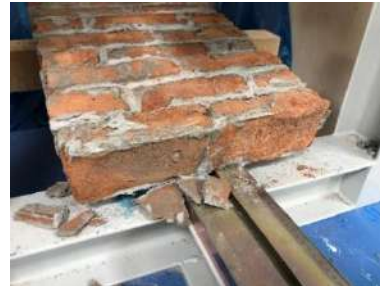
**Figure 8.** Failure mode of control specimen [31]

The control specimen reached/achieved a load of 2.39 kN with a displacement of 0.95 mm and collapsed with a brittle manner. As seen in Figure 8, the collapse occurred at the mortar interface. There was no damage to the solid bricks forming the masonry panel walls.

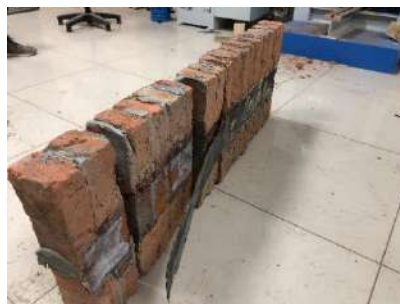
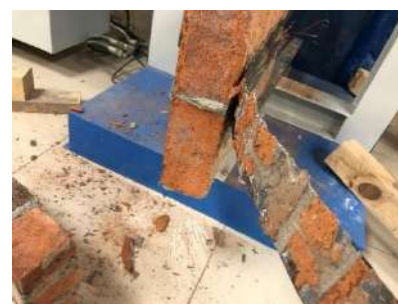
**Figure 9.** Failure mode of S-S1-L1 [31]

The specimen S-S1-L1 reached/achieved a load of 20.09 kN with a displacement of 12.71 mm, and because of debonding of the CFRP strip from the masonry surface, the specimen suddenly lost its bearing capacity and

collapsed. In the middle part of the masonry wall, it was observed that the solid bricks were crushed because of compression (Fig.9).

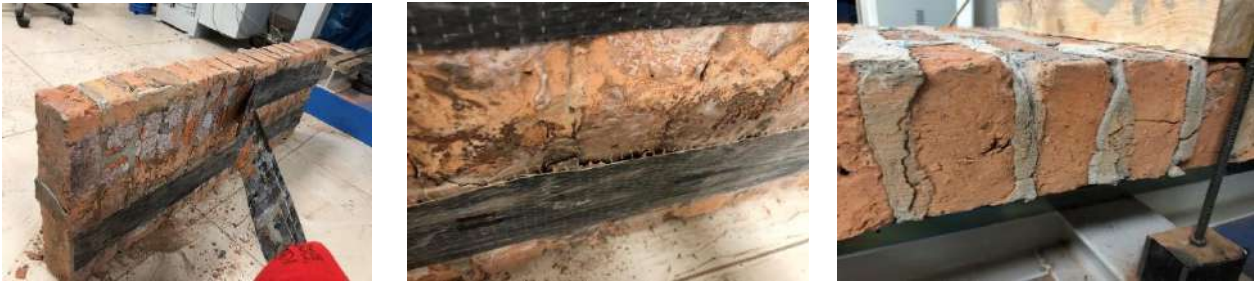
**Fig 10.** Failure mode of S-S2-L1 [31]

The specimen S-S2-L1 reached a load of 22.81 kN with a displacement of 14.33 mm. The specimen suddenly lost its bearing capacity and collapsed because of debonding of the CFRP strip from the masonry surface. One of the strips deboned from the surface and the other one continued to contribute to the bearing capacity despite locally debonding of it. It is thought that the reason why these two strips do not collapse at the same time is a workmanship fault. Because the behavior of the strips was not identical even though there were identical loads on both strips.

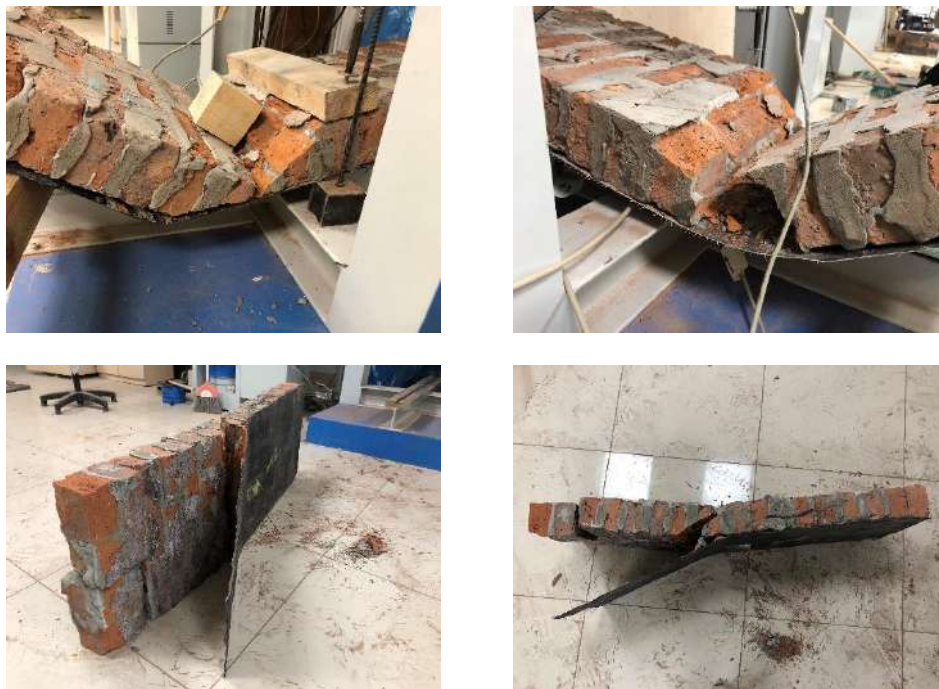
**Figure 11.** Failure mode of S-F-L1 [31]

The specimen S-F-L1 reached a load of 43.04 kN with a displacement of 14.04 mm. Although the failure mode of the test specimen is similar with the other strengthened test specimens, the increase in the bearing capacity is quite remarkable.

As shown in Figure 11, solid bricks had large cracks and damage unlike other specimens. In other words, the specimen did not collapse due to the damages at the mortar interface. It determined that the solid bricks that make up the specimen reached the bearing capacity and were failure to compression and shear (complex) collapse.
