SEISMOLOGICAL, GEOTECHNICAL AND STRUCTURAL ASPECTS OF THE 2023 KAHRAMANMARASH, TURKEY EARTHQUAKE SEQUENCE

Erberik Murat- prof., Department of Civil Engineering, Middle East Technical University, Turkey

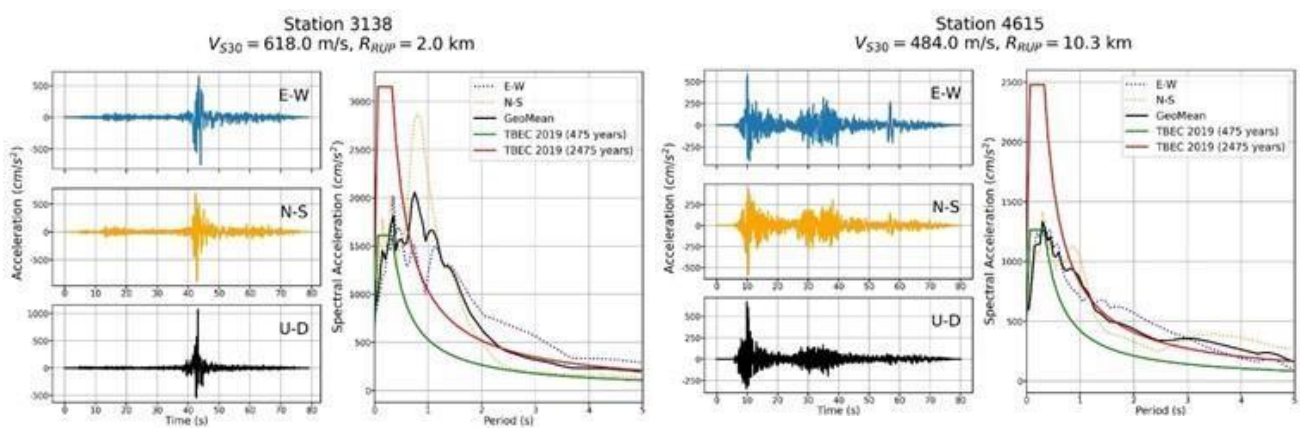
Figure 4 displays two selected records from the first earthquake. The rupture distances and site conditions are also provided. The station with code 3138 is located on relatively stiff soils in Hasşa, Hatay. The response spectra of the horizontal components are very broadband in nature and they exceed the maximum design earthquake at almost all periods while they exceed also the maximum credible earthquake level at longer periods. Station 4615 is located in relatively softer soil conditions in Pazarcik, Kahramanmaraş.

Figure 4. Acceleration time histories and response spectra at selected stations that recorded the Mw=7.7 Kahramanmaras earthquake (figures are modified from the originally published versions in [19])

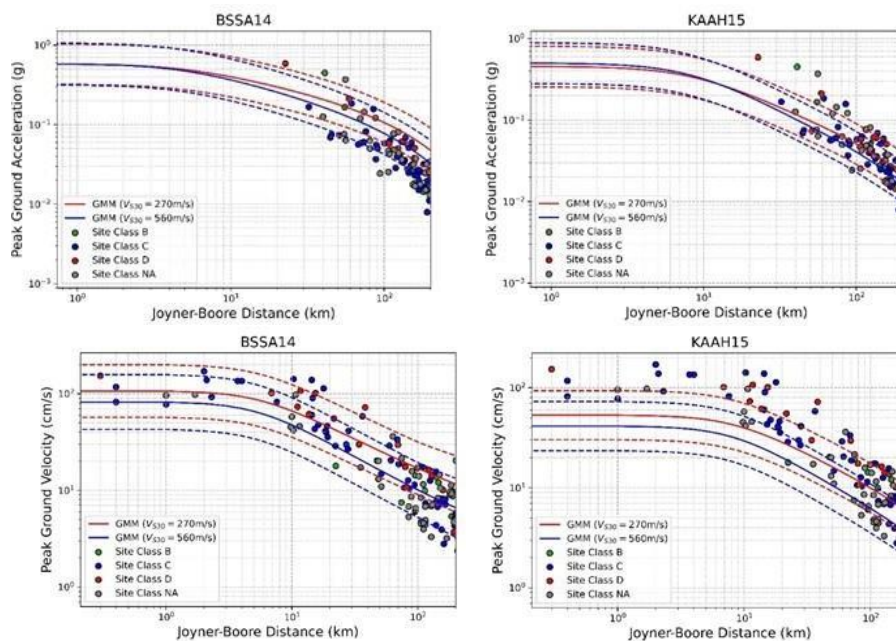
Next, a comparison of the recorded strong motions against two existing ground motion models is made. Figure 5 demonstrates the recorded PGA and PGV levels against models by [20] and [21], respectively. The comparisons show that PGA values overall confirm the median estimates of GMMs with a few exceptions. However, PGV values overestimate the median levels of the GMMs. This could be attributed to long-period enhancements from basin effects, forward directivity pulses, or local soil behavior. Further conclusions can be obtained by performing detailed residual analyses for PGA, PGV as well as spectral accelerations.

Figure 5. Comparison of recorded peak ground motions against selected empirical models [19]
